Mangawhai Wastewater Treatment – Disposal Field

Irrigation Assessment

Date: 11/02/2019

Reference: 1-13586.01

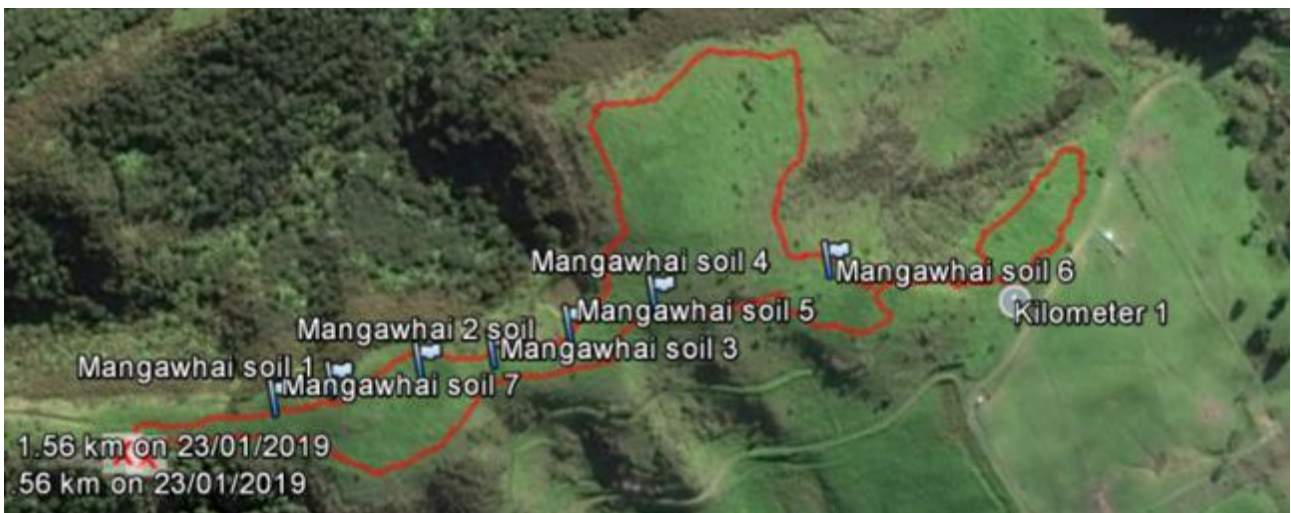
Figure 2 - : Soil profile and feasible area map. Area within red is approx. 2.4 ha

Soil profiles were exposed from holes dug by spade and augering; observations occurred at track cuttings and other places where the soil could easily be exposed. Representative profiles were described in general accordance with Milne et al 1995 and photographed. Figure 2 highlights where each soil hole was located.

Based on all field work and site observations the 13 ha site two land management units were identified. The distinguishing feature between the two units is the slope. The first unit was approximately 2.4 ha and has slopes less than 20°. The second land management unit has slopes greater than 20°.

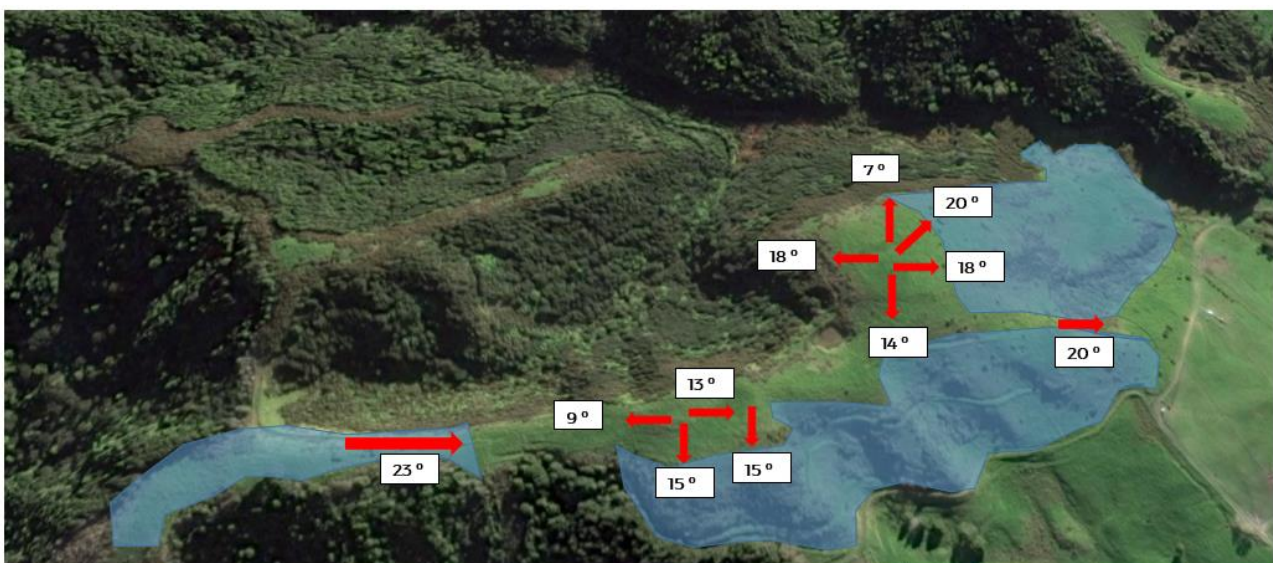
Figure 3 - Slope map

Figure 3 below highlights the varying slopes across the 13 ha. An area of approximately 2.4 ha had slopes ranging between 0° and 20° and from this aspect this area could be suitable for irrigation. The soil survey undertaken focused on this area.

All areas highlighted in blue have a slope greater than 20°. This area covers 10.6 ha of the 13 ha block. Generally, land with slopes greater than 20° would not be suitable for irrigation due to increased risk of surface run off. Due to this a soil survey was not completed on this area.

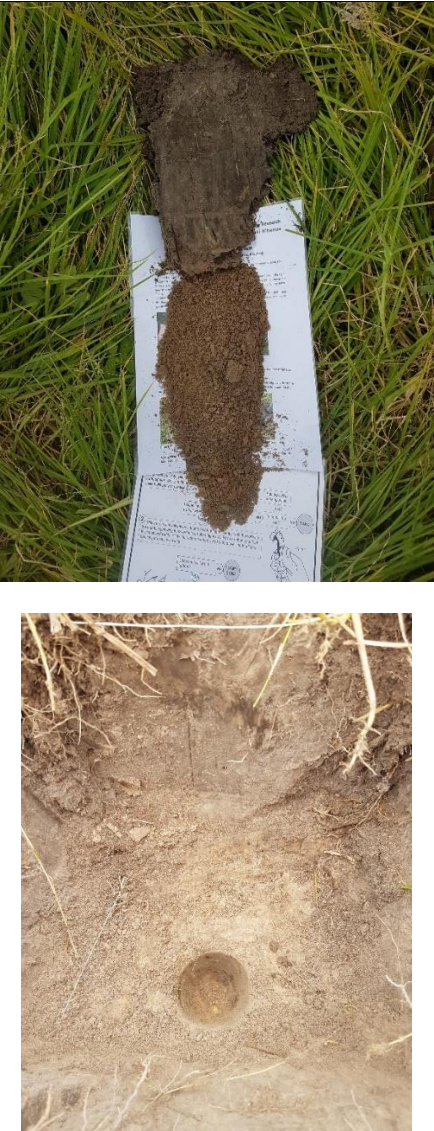
Soil Description	Photo
<p>A 0-25 cm Silty clay 10 YR 2/2 very dark brown Crumb structure Moderately developed Very Friable No mottles or gleying Distinct boundary change</p> <p>B 25-40 cm Silty clay - very smooth 10 YR 4/2 dark greyish brown Crumb structure Weakly developed Distinct boundary change</p> <p>C 40+ cm Silty clay 10 YR 7/6 yellow Platety structure No Development</p> <p>Red on soil map</p>

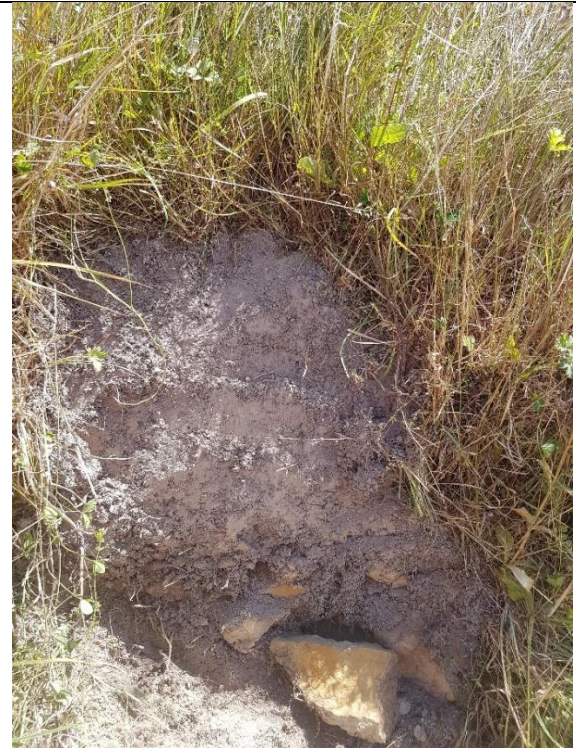
Yellow on soil map

A 0-15 cm
 Silty clay
 10 YR 3/2 very dark grayish brown
 Crumb structure
 Moderately developed
 Very Friable
 No mottles or gleying
 Faint boundary change

B 15-55 cm
 Silty clay loam/silty clay
 10 YR 3/2 very dark grayish brown
 Crumb structure
 Weakly developed
 Distinct boundary change

C 55+ cm
 Rock
 10 YR 6/4 light yellowish brown

Note: some topsoil missing, another hole of same soil had an A horizon of 0-25 cm. Track side cutting which was a lot drier than soil hole.

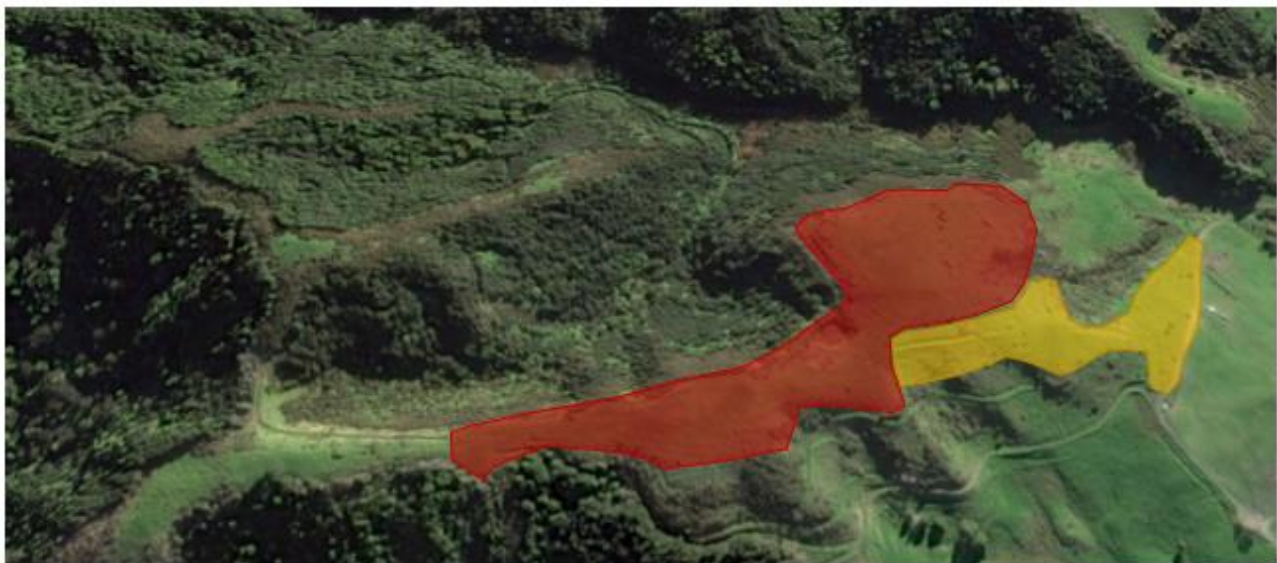
Figure 4 - Soil map

Based on the field work two soil types were identified on the property. Both soils had silty clay top soils and subsoils. The nature of these soil in addition to the high rainfall of this location has the following implications for wastewater irrigation:

1. The number of suitable days through the year suitable for deferred irrigation is less than a free draining silt loam soil in a region where the rainfall is lower;
2. The application rate required to prevent nutrient and bacterial loss through run-off would need to be a low rate. The silty clay soil texture increases the risk of run-off compared to other soil textures due to lower infiltration capacity;

Figure 4 highlights the areas where each soil type is located. A description and photo for each soil is presented below:
