Geotechnical Assessment West Coast Sites Kaipara District

Submitted to:
Mr Paul Waanders
Kaipara District Council
42 Hokianga Road
Dargaville 0310

01.05.2019
15601.000.005_02

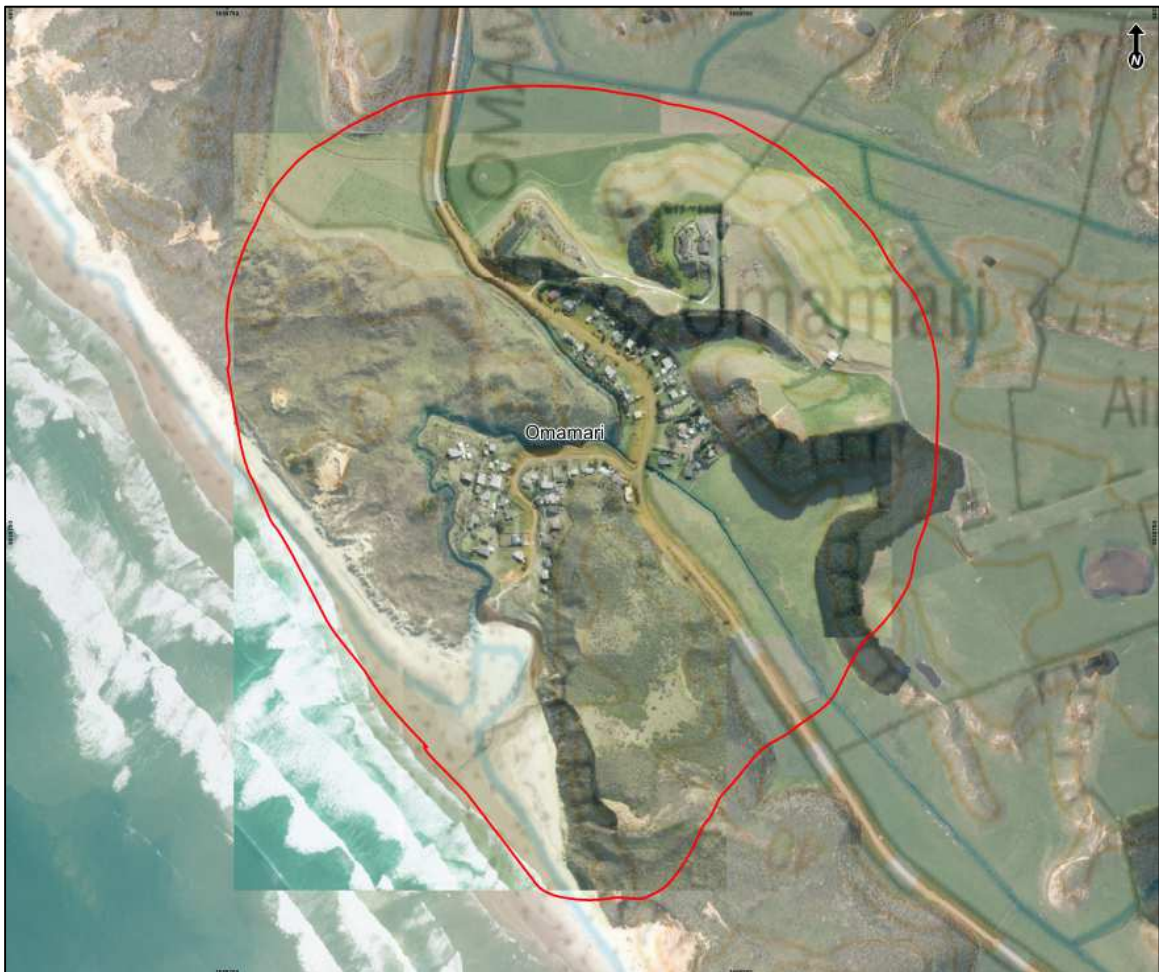
Figure 2: Indicative Growth Area – Omamari

Image sourced from Eagle Technology, CC-BY-3.0. The Indicative Growth Area boundary was provided by Kaipara District Council. Not to Scale.

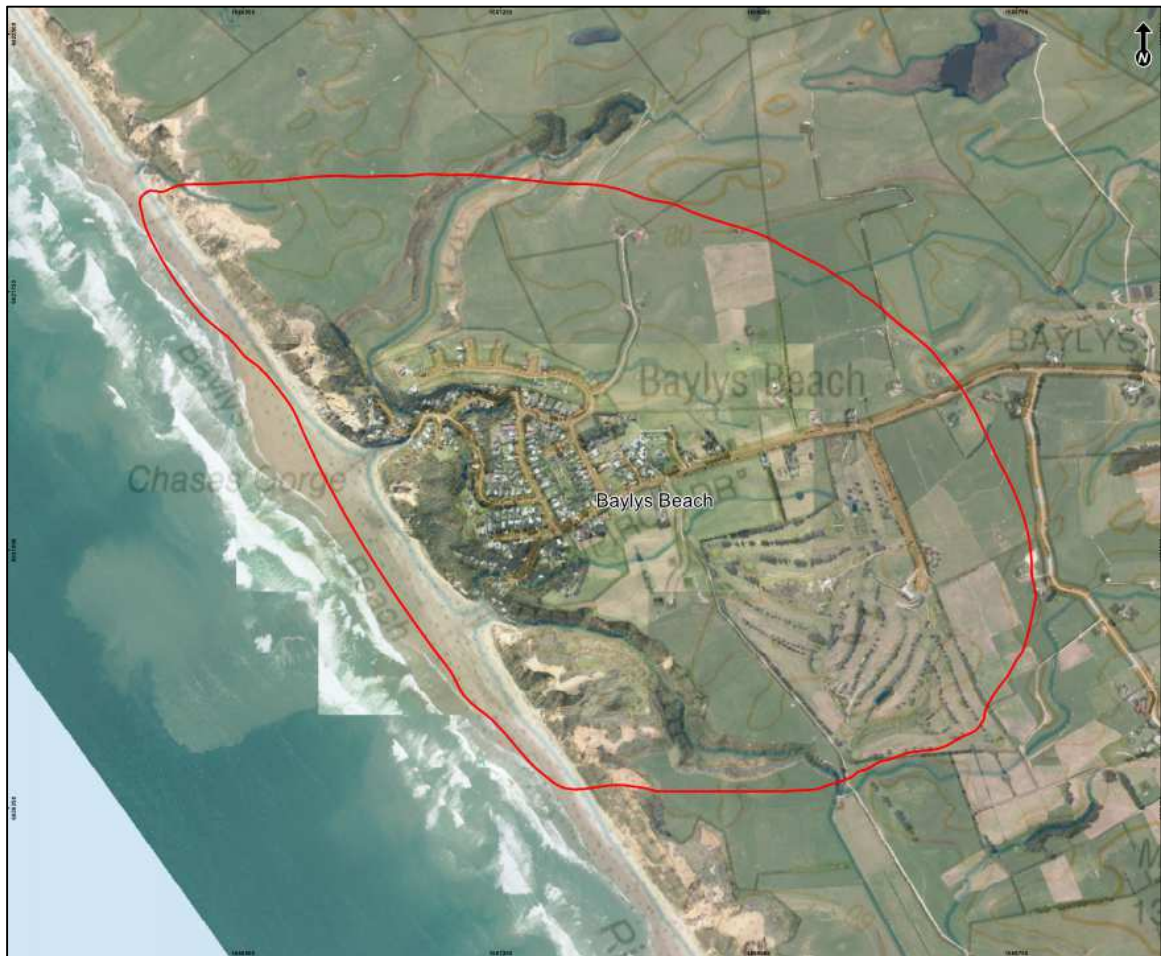
Figure 3: Indicative Growth Area – Baylys Beach

Image sourced from Eagle Technology, CC-BY-3.0. The Indicative Growth Area boundary was provided by Kaipara District Council. Not to Scale.

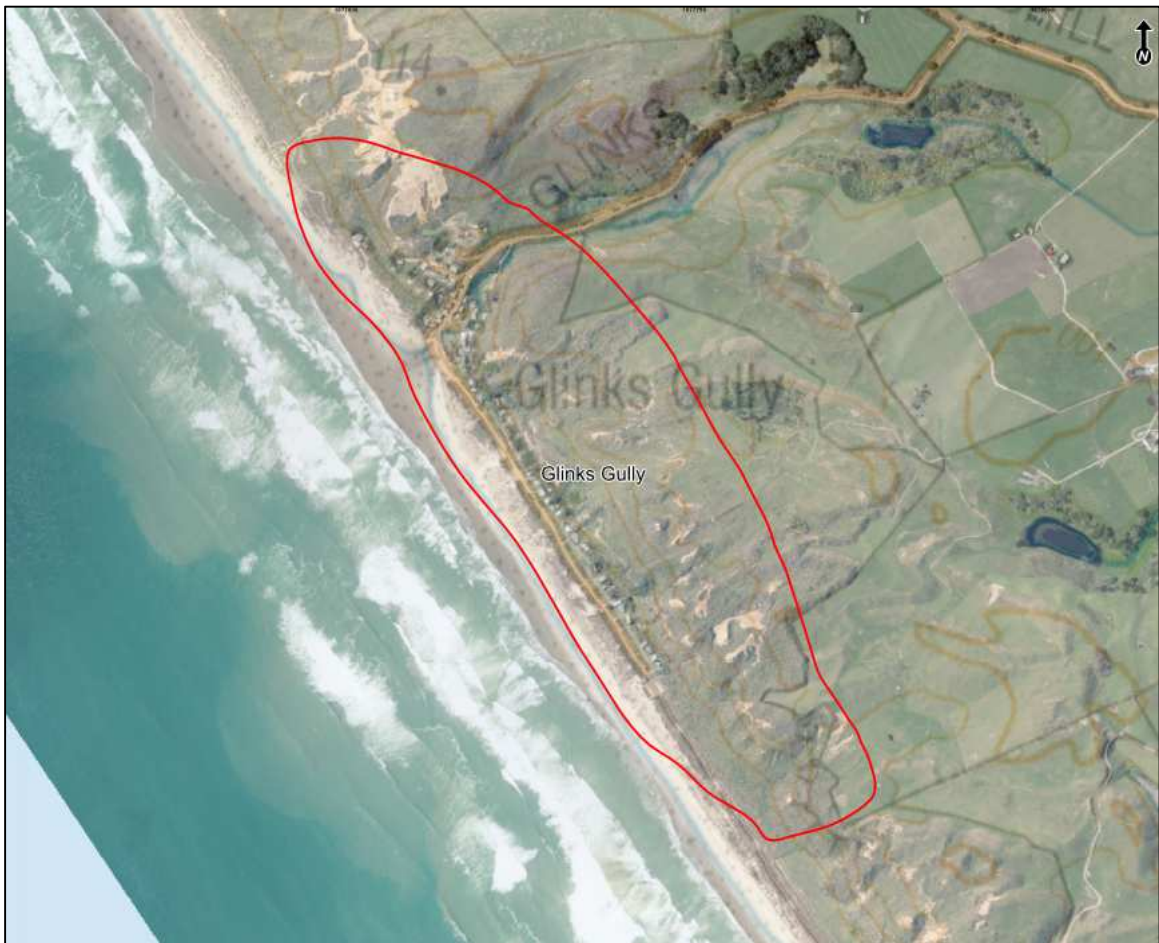
Figure 4: Indicative Growth Area – Glinks Gully

Image sourced from Eagle Technology, CC-BY-3.0. The Indicative Growth Area boundary was provided by Kaipara District Council. Not to Scale.

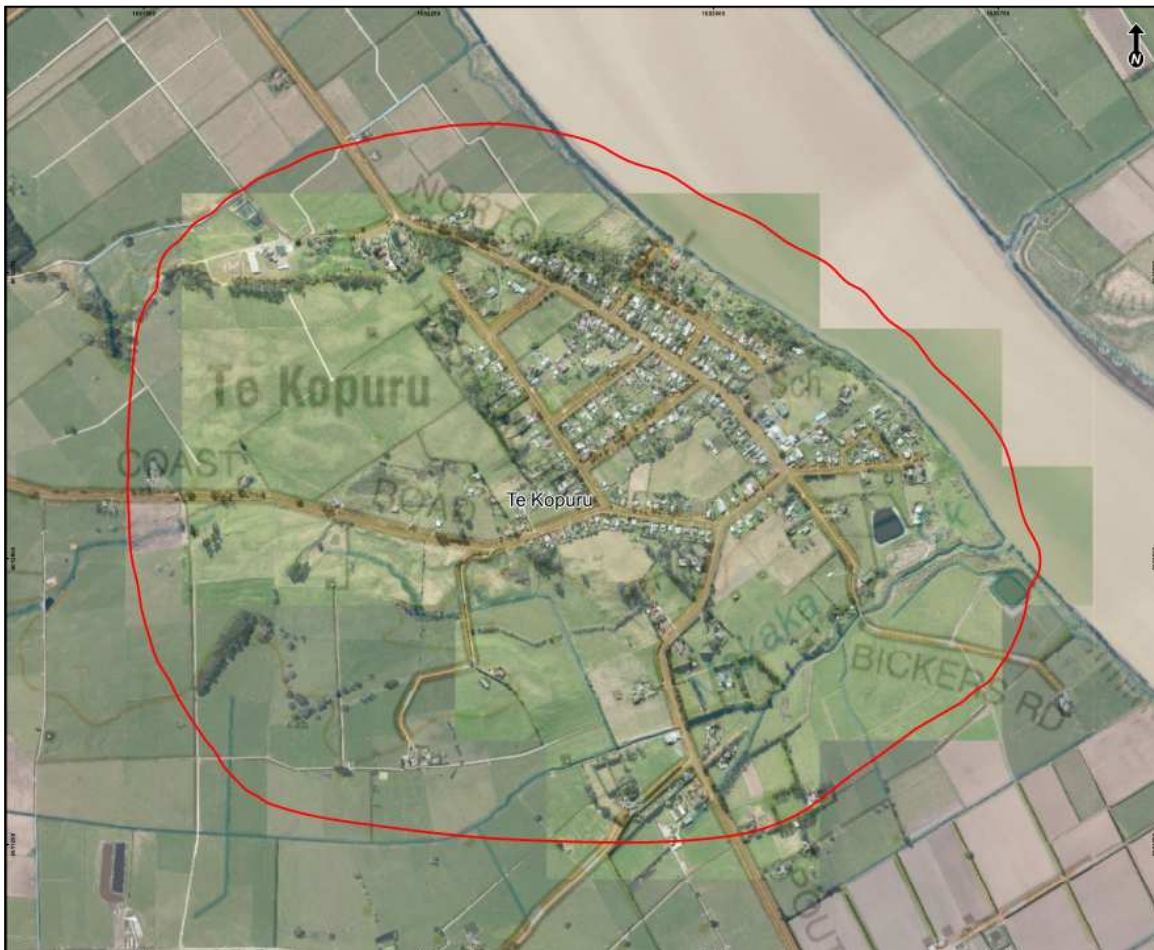
Figure 5: Indicative Growth Area – Te Kopuru

Image sourced from Eagle Technology, CC-BY-3.0. The Indicative Growth Area boundary was provided by Kaipara District Council. Not to Scale.

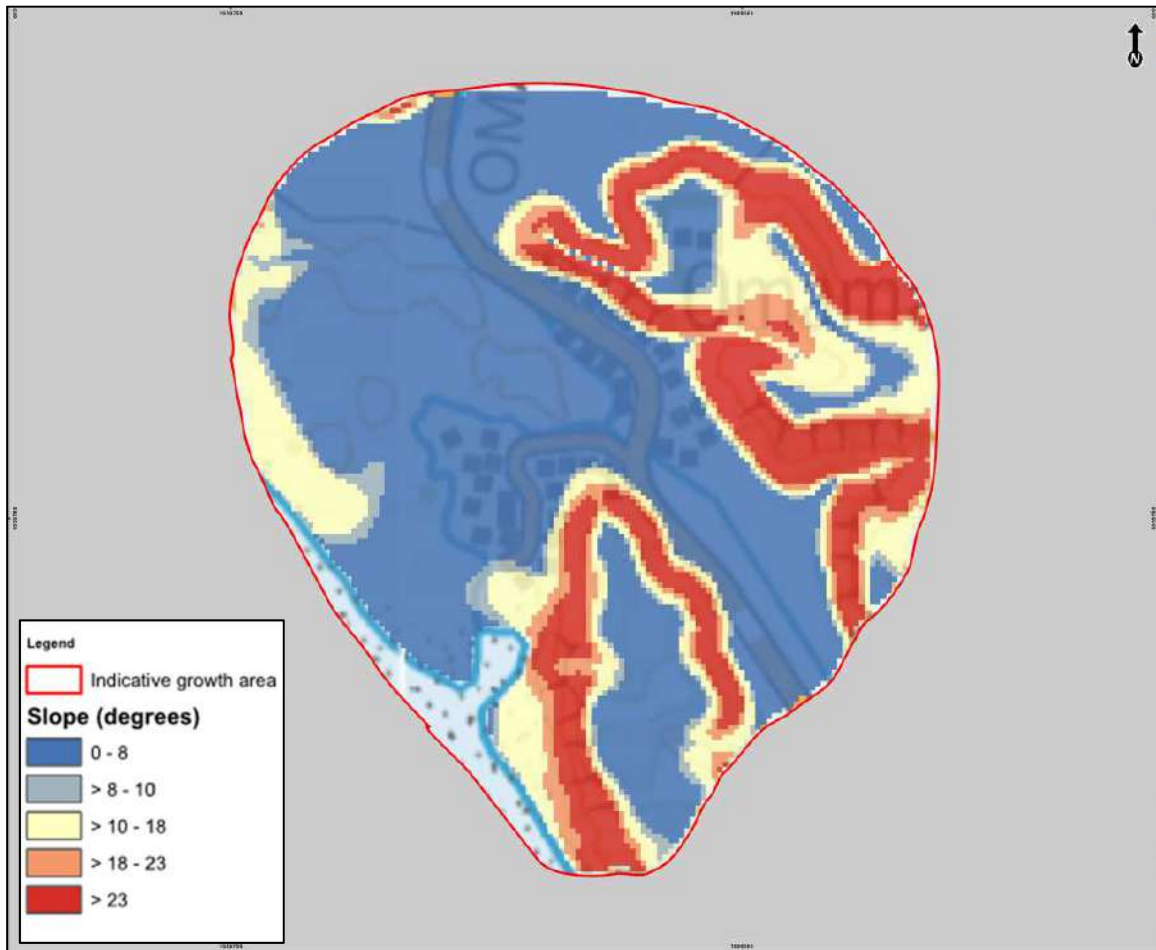
Figure 10: Topographic Slope Angles – Omamari

Image sourced from Land Information New Zealand, CC-BY-3.0. Not to Scale.

A profile of existing slope angles was created using LINZ Topo50 20 m contours (vertical accuracy ≤ 10 m). From this, a digital elevation model (DEM) was generated, and then a Slope Profile (Figure 4) was produced to show relative steepness within the study area.

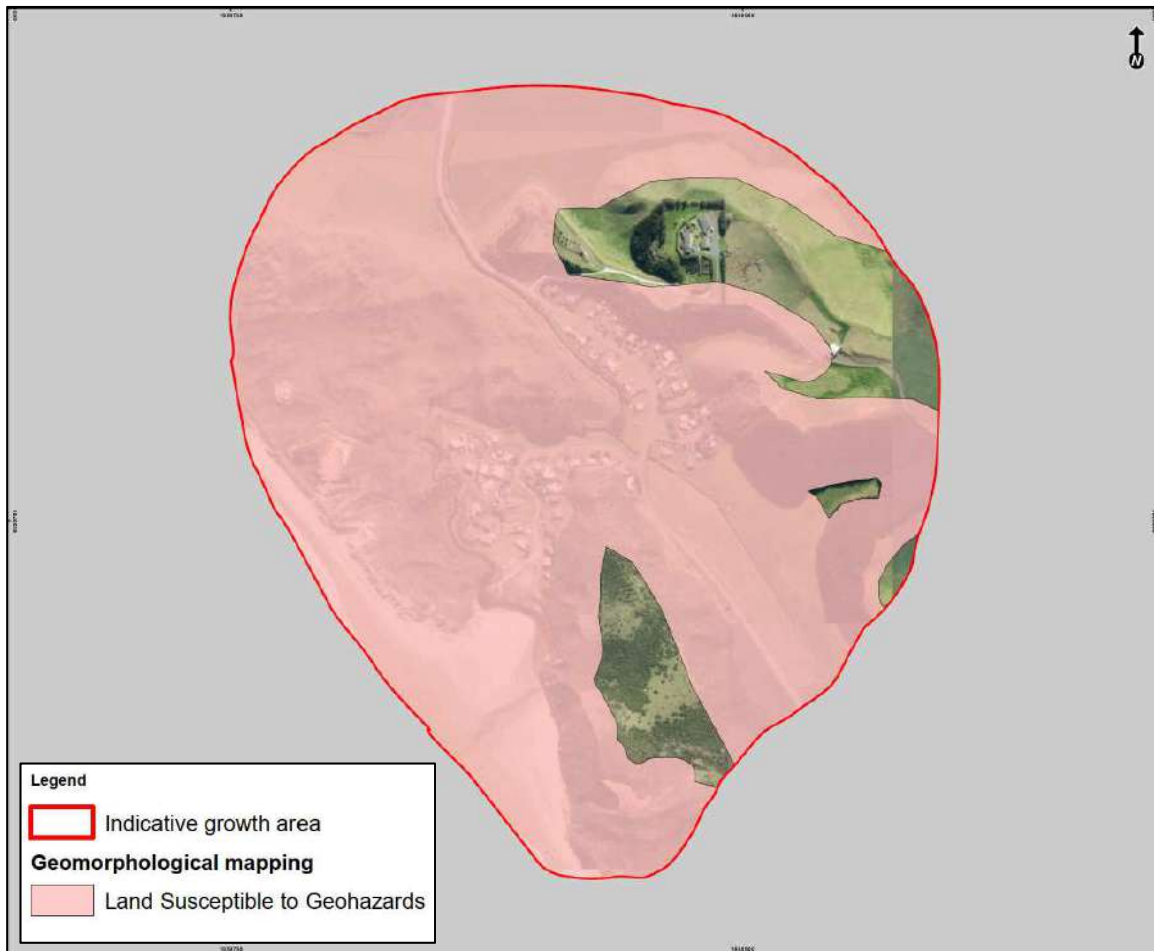
Figure 14: Geomorphological Mapping – Omamari

Base image sourced from Land Information New Zealand, CC-BY-3.0. Not to Scale.

The geomorphic mapping performed for this study should be considered a reconnaissance level effort, and is intended to provide a generalised delineation of geotechnical hazards for planning-level site evaluations. The accuracy was limited by the scale of the aerial images and other factors such as vegetative cover, farming, and urban development. The mapping depicted on Figures 14 through 17 should be supplemented by detailed site-specific geomorphic mapping for design level studies.

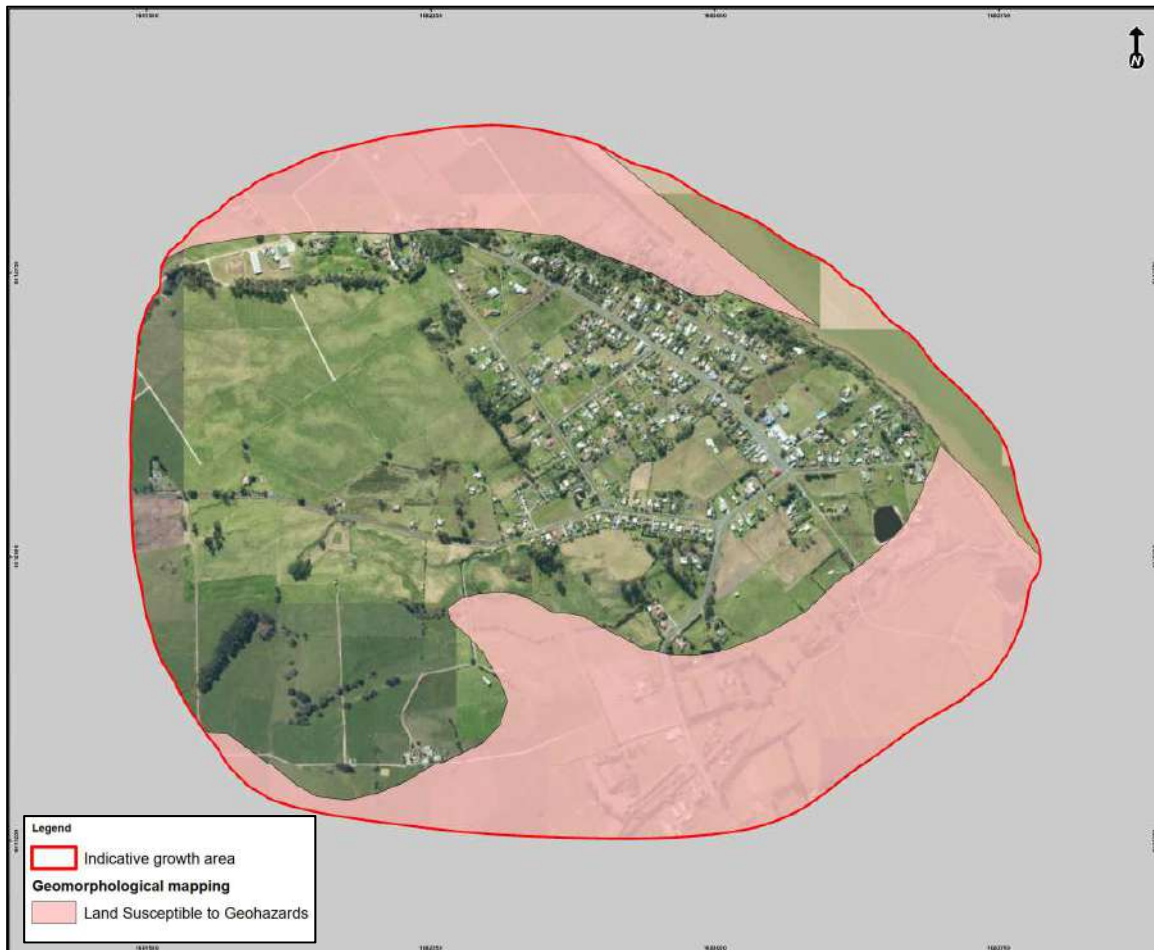
Figure 17: Geomorphological Mapping - Te Kopuru

Base image sourced from Land Information New Zealand, CC-BY-3.0. Not to Scale.

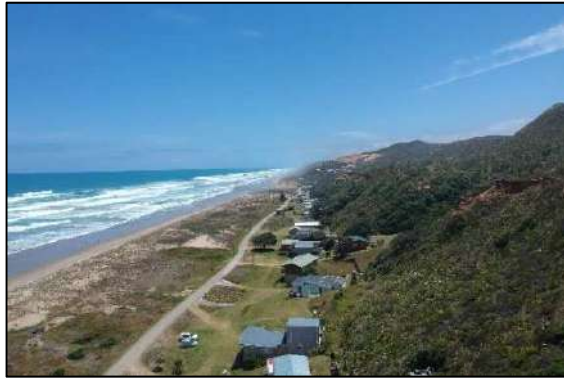
Photo 1: Drone photo looking northwest from the south of the Glinks Gully study area.

The variably vegetated dunes along the coast extend from the beach up to over approximately 60 m in elevation (Photos 1 and 2). The landform remains generally stable up to approximately 70 degrees (Photo 3), however shallow instability features are present on some of the vegetated slopes, and erosion and pervasive slope instability is evident in sparsely vegetated areas and areas influenced by water (i.e. overland flow paths), particularly at the coast (Photos 4 and 5).

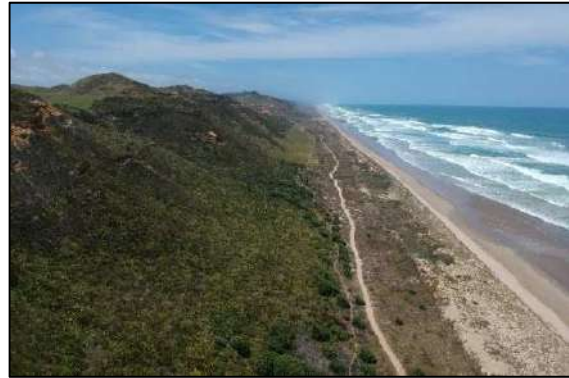
Photo 2: Drone photo looking southeast from the south of the Glinks Gully study area.

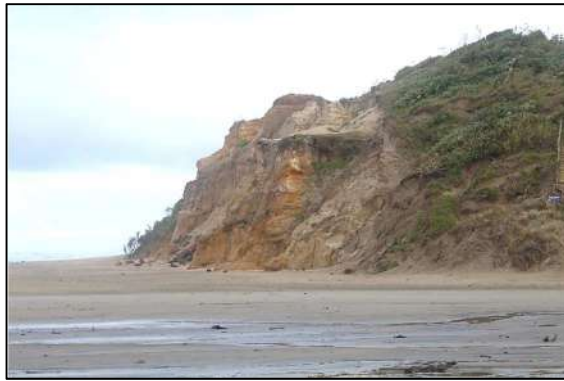
Photo 3: Steep dune on the coast at Baylys Beach.

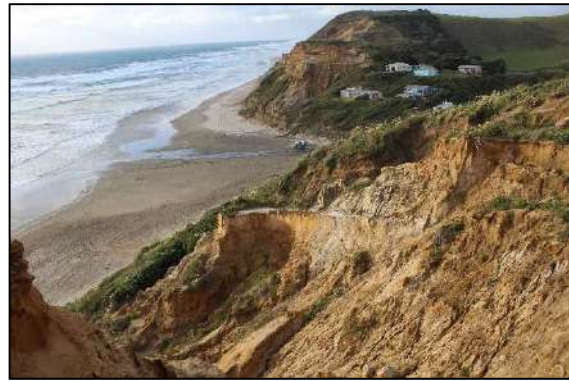
Photo 4: Erosion of the dunes at Baylys Beach.

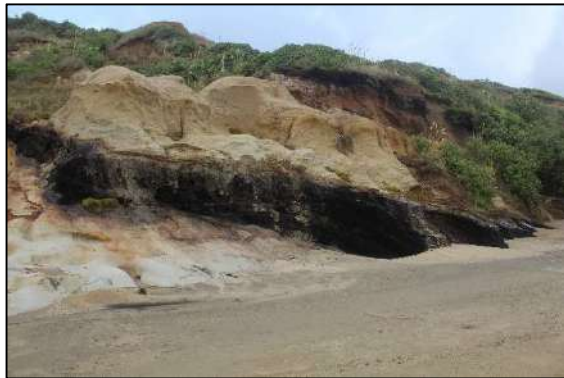
Photo 5: Up to approximately 1 m thick lignite outcrop exposed at the coast in the south of the Baylys Beach study area.

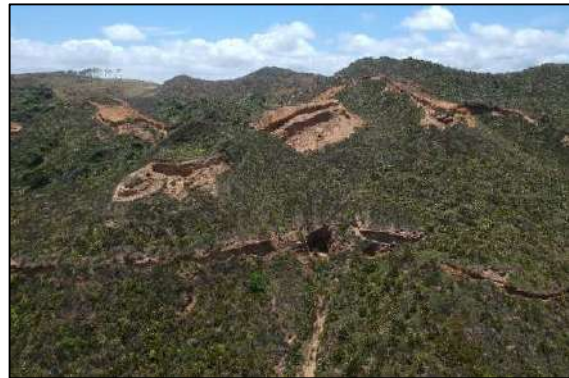
Photo 6: Drone photo of exposed paleosols in the upper part of the dunes at Glinks Gully.

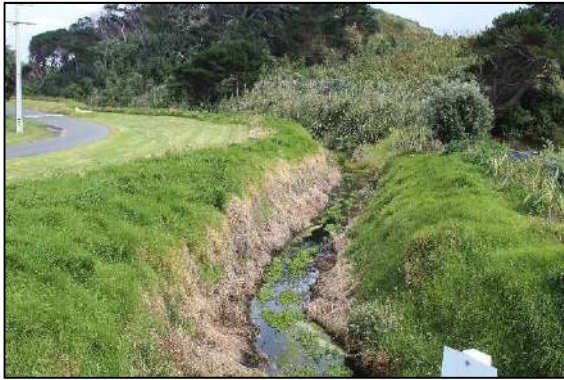
Photo 7: Steeply incised stream in the north-western part of the Omamari study area.

Inland, the hill systems are bisected by broad valleys and steeply incised streams (Photo 7), which generally flow through the central part of the focus areas and drain through to the coast. In Omamari, a low-lying inland valley (Photo 8) underlain by alluvium extends approximately parallel to the coast and drains through the central portion of the study area to the beach.

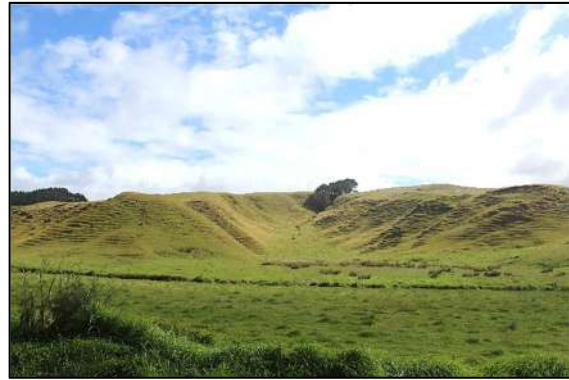
Photo 8: Broad valley and gully with dune terraces in the northern part of the Omamari study area.

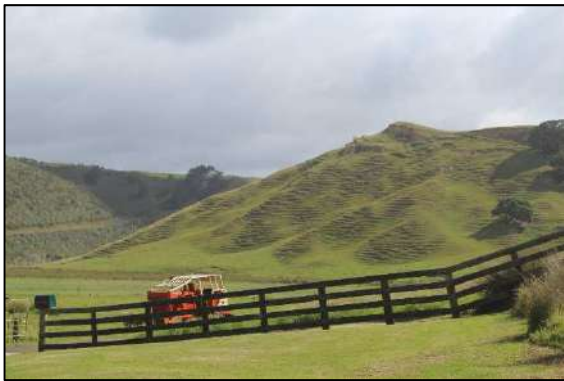
Photo 9: Hummocky land and terracettes on a slope in the north of the Omamari study area.

Shallow slumping and soil creep are generally caused by loose, unconsolidated sediments that have failed along over-steepened slopes or have slowly moved downslope through the action of gravity. These features are often difficult to observe at 1:25,000 scale aerial photographs, and are best observed during geomorphological mapping. Features of slumping and soil creep often present as hummocky landmass and formation of terracettes (horizontal soil ridges).

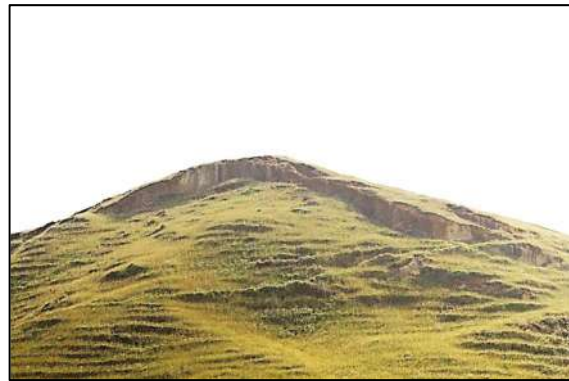
Photo 10: The headscarp of a large landslide and evidence of shallow soil creep in the southern Omamari study area.

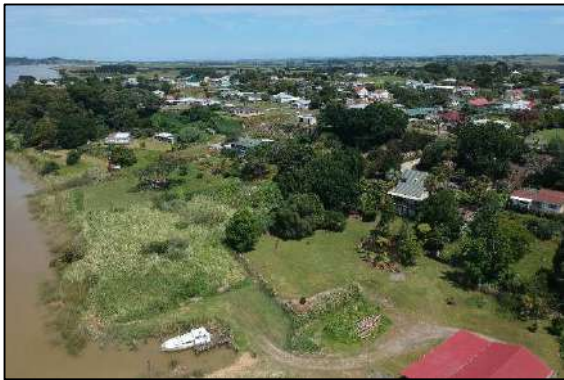
Photo 11: Drone photo looking south from the boat ramp in the northeast of the Te Kopuru study area.

In the Te Kopuru study area, the landform is dominated by an elevated terrace in the central area (Photo 11), underlain by Awhitu Group fixed dunes, and a low-lying, relatively level Holocene-aged alluvial plane in the southeast and southwest of the study area (Photo 12). Rolling hills and moderate slopes were observed in pasture land at the geological boundary in the southern part of the study area. Whereas a steep, weak to extremely weak sandstone outcrop was observed at the boundary near the boat ramp in the north-eastern part of the study area (Photo 13). The majority of the township is located on the elevated area, while the low-lying areas are predominantly utilised for agricultural purposes.

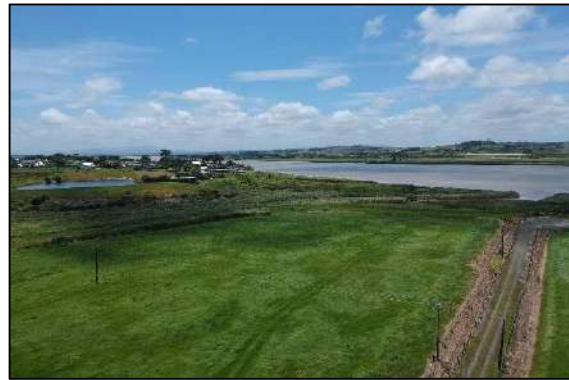
Photo 12: Drone photo looking east along Bickers Road in the southeast of the Te Kopuru study area.

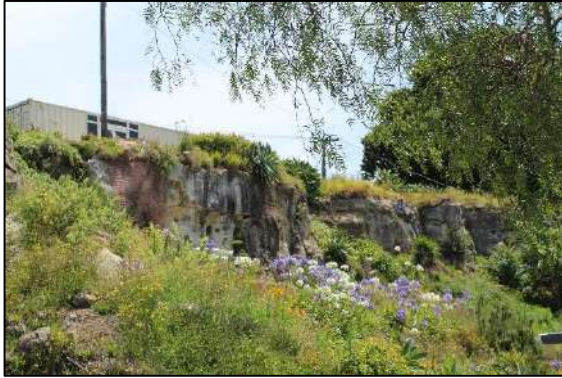
Photo 13: Exposed Awhitu Group (Pad) sandstone in the northeast of the Te Kopuru study area.

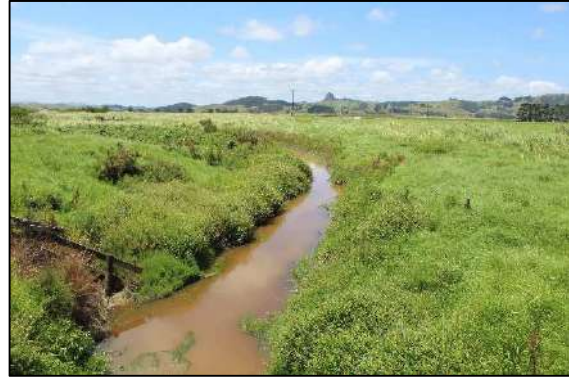
Photo 14: Low lying stream in the southern part of the Te Kopuru study area.

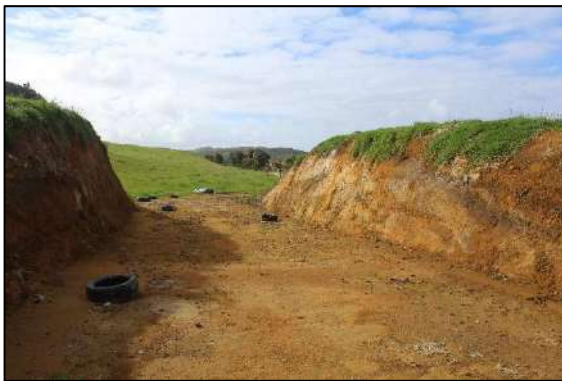
Photo 15: Inferred open borrow pit located in the southeast of the Baylys Beach study area.

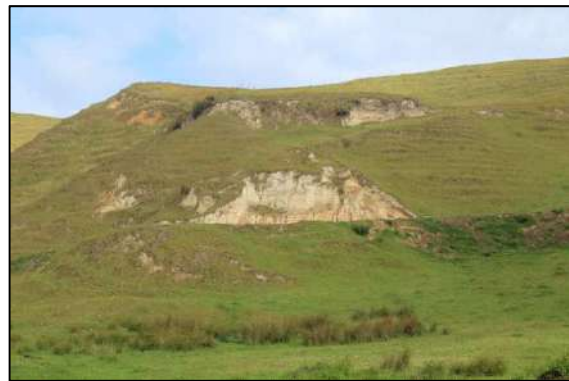
Photo 16: Inferred open borrow pit located to the northeast of the Baylys Beach study area.
