Geotechnical Assessment

Maungaturoto
Kaipara District

12.03.2019
15601.000.000_03

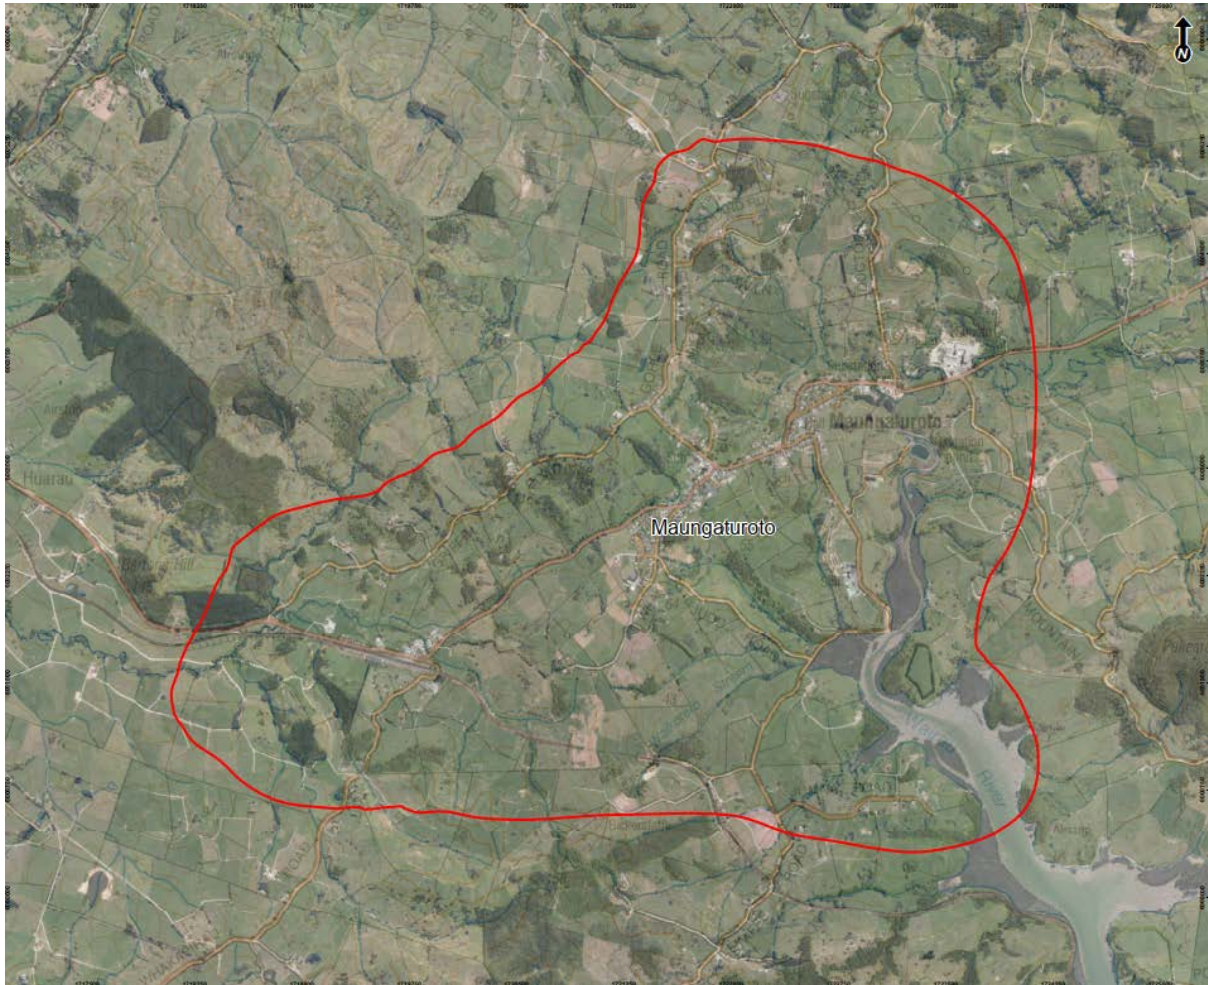
Figure 2: Indicative Growth Area

Image sourced from Eagle Technology, CC-BY-3.0. The Indicative Growth Area boundary was provided by Kaipara District Council. Not to Scale

The study area includes State Highway 12, Griffin Road, Doctor Hill Road, Mountain Road, Gorge Road, Bickerstaffe Road, Whakapirau Road, KiwiRail's North Auckland Line (NAL), the township of Maungaturoto and the commercial, industrial and residential developments within the township, large paddocks used for farming and horticulture, and the mouth of the Wairau River. The vicinity of the study area is shown in Figure 1, and the Maungaturoto Indicative Growth Area is shown in Figure 2.

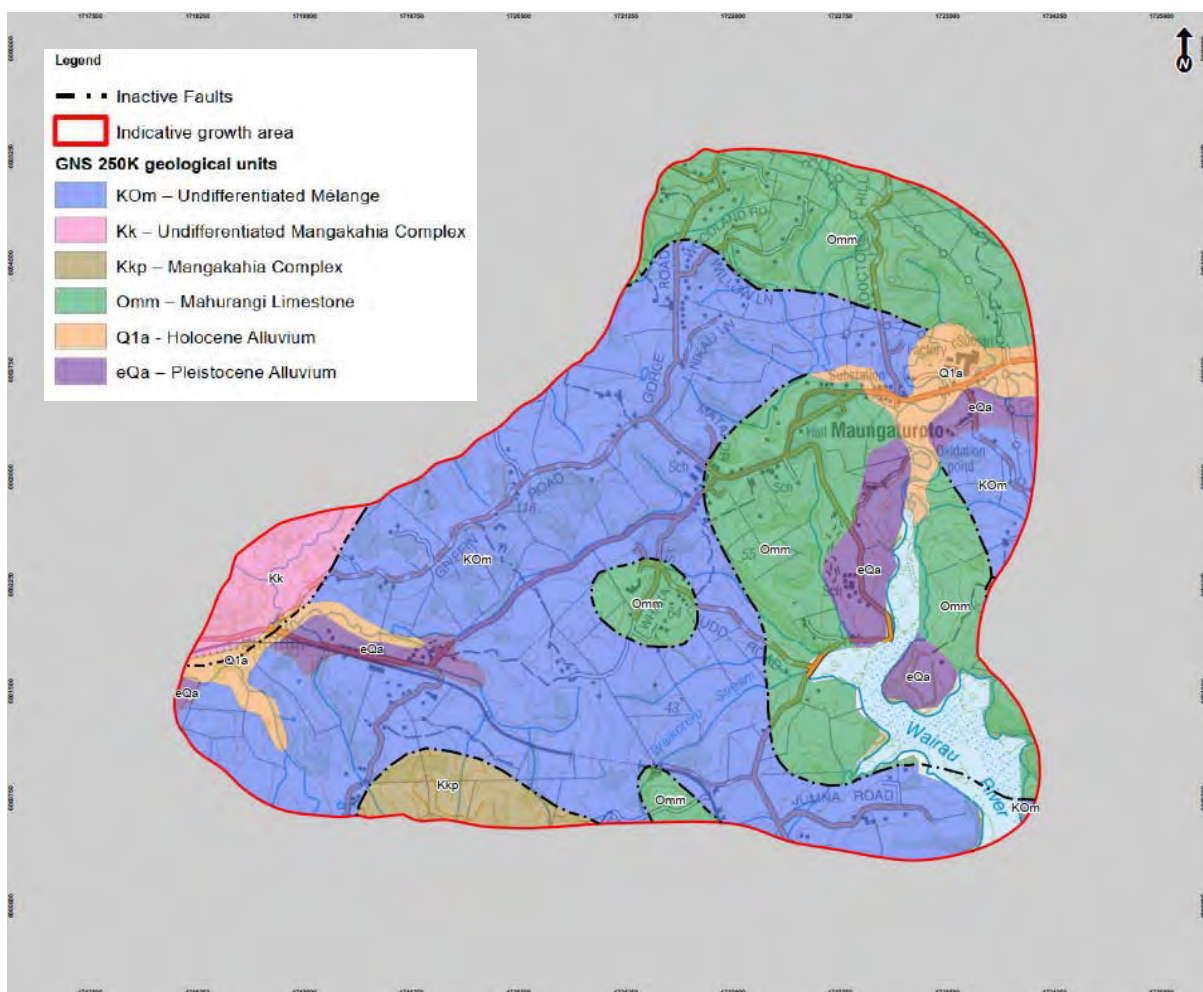
Figure 3: Geology Map

The map has been adapted to create Figure 3, depicting the surface expression of the geological units mapped across the study area.

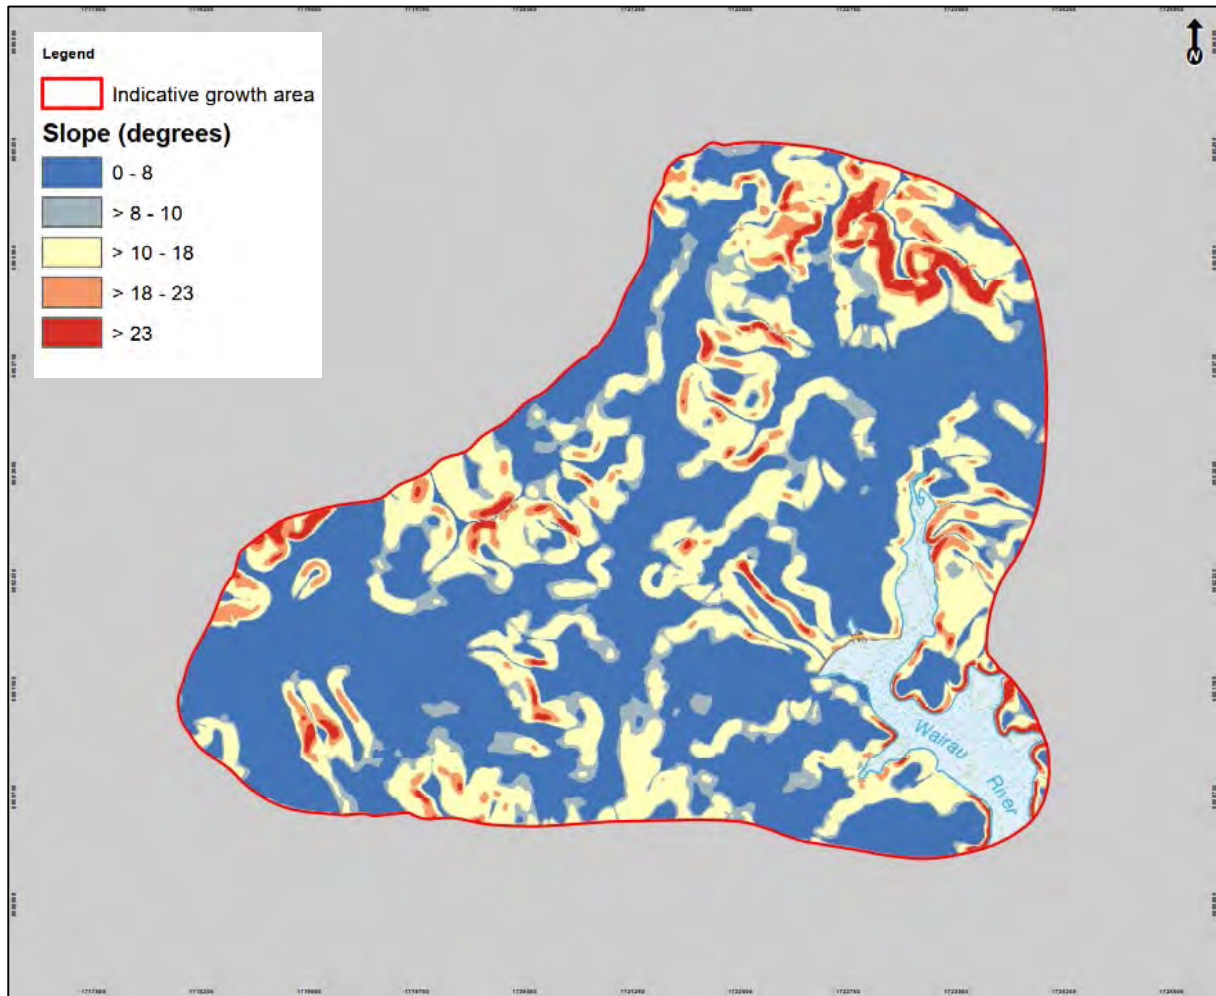
Figure 4: Topographic Slope Angles

A profile of existing slope angles was created using LINZ Topo50 20 m contours (vertical accuracy $\leq 10\text{m}$). From this, a digital elevation model (DEM) was generated, and then a Slope Profile (Figure 4) was produced to show relative steepness within the study area.

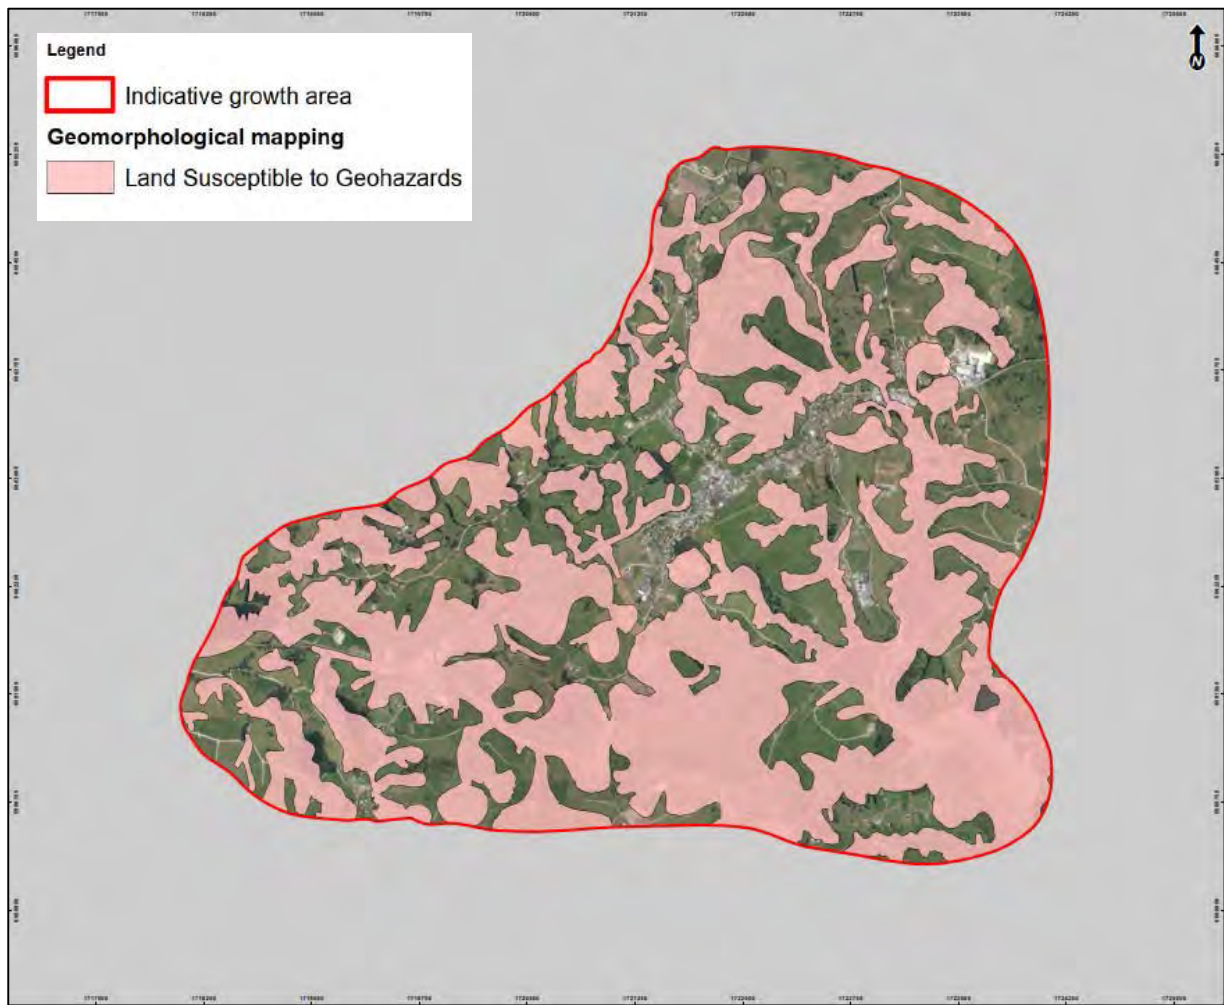
Figure 5: Geomorphological Mapping

The geomorphic mapping performed for this study should be considered a reconnaissance level effort, and is intended to provide a generalised delineation of geotechnical hazards for planning-level site evaluations. The accuracy was limited by the scale of the aerial images and other factors such as vegetative cover, farming, and urban development. The mapping depicted on Figure 5 should be supplemented by detailed site-specific geomorphic mapping for design level studies.

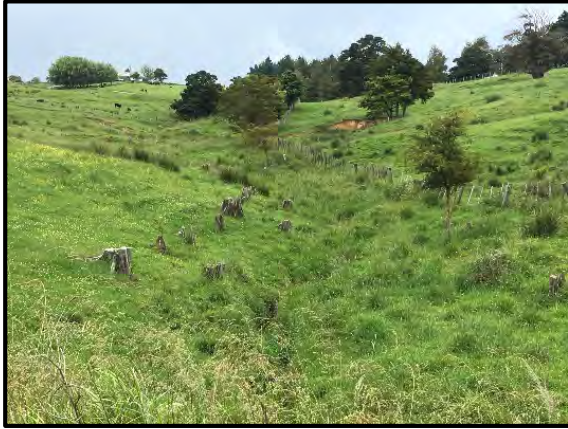
Photo 1: Typical drainage. Note the active landslide along the low angle slopes and swampy ground in the lower right.

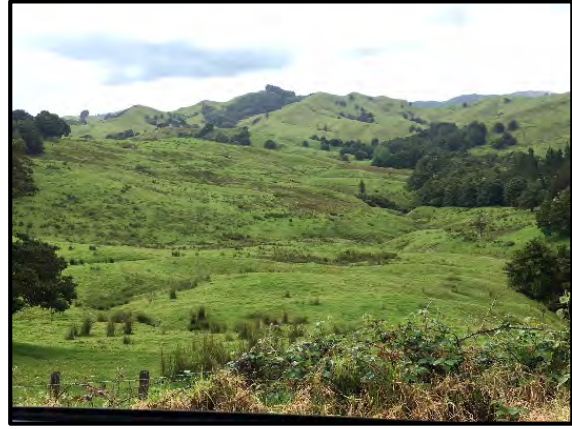
Photo 2: Typical landscape featuring hummocky, irregular ground, inferred landslide debris, and soil creep.

The rolling hills are well vegetated and express widespread evidence of historical slope instability, as well as active slope instability (Photo 2). This is primarily expressed in the form of shallow rotational failures and hybrid rotational / translational failures. Mid-slope benches and arcuate head scarps were observed on many of the moderate (16-30 degrees) to steep (>31 degrees) slopes. Active soil creep, particularly in the form of terracettes, was evident over much of the study area (Photo 3).

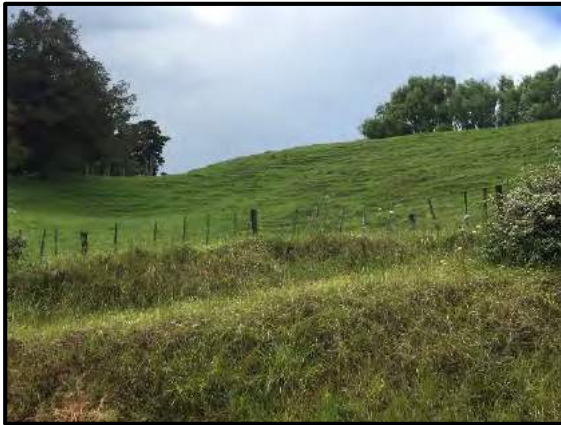
Photo 3: Shallow instability and soil creep in the form of horizontal soil ridges.

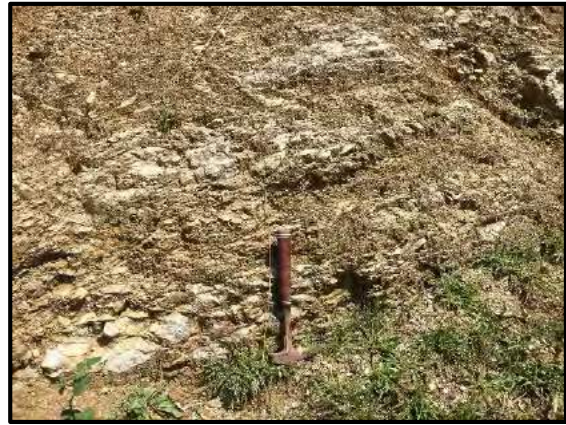
Photo 4: Crushed mudstone (KOM) outcropping southeast of State Highway 12, northeast of the intersection of Highway 12 and Whakapirau Road.

Only limited areas were observed to have rock outcrops. Where exposed, we observed weak to extremely weak, very thinly bedded to laminated, sheared and crushed mudstone (Photo 4). Mudstone observed in the south-western portion of the study area, between State Highway 12 and the railroad, was inferred as sheared Mangakahia Complex mudstone, as part of the regionally mapped Undifferentiated Mélange (KOm). Sheared mudstone was observed approximately 1 kilometre south of the study area within a road cut on Bickerstaffe Road (Photo 5). This outcrop featured discontinuous layers of very soft ash, with an estimated undrained shear strength of less than 12 kPa.

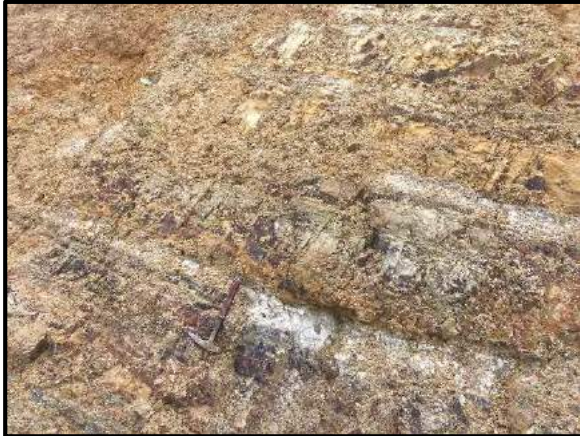
Photo 5: Crushed mudstone located approximately one kilometre south of the study area. Note the discontinuous ash layers within.

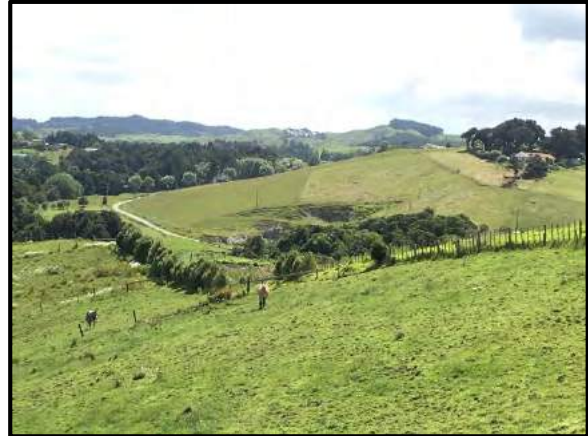
Photo 6: Possible open pit borrow area. Note the failing batters where quarry cuts have over-steepened the slopes.

Two areas were observed during our site visit that appeared to be open borrow areas (Photo 6 and 7). These were likely local quarry sources for farm improvements or roading. Local areas of instability were observed near the crest of the excavations due to the over-steepened nature of the slopes. A discussion on geotechnical hazards associated with open pit quarries is in Section 1.1.

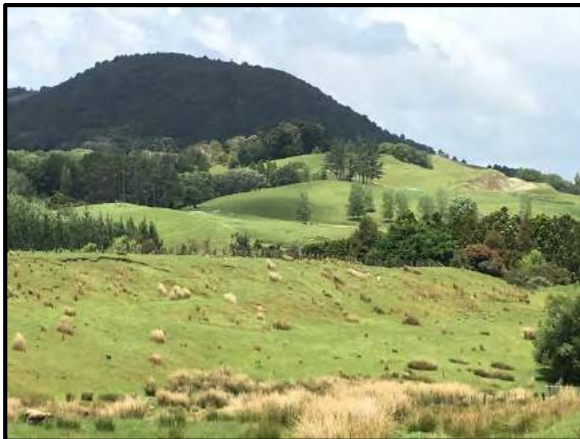
Photo 7: Failing slopes in the foreground and possible borrow pit in the upper right.

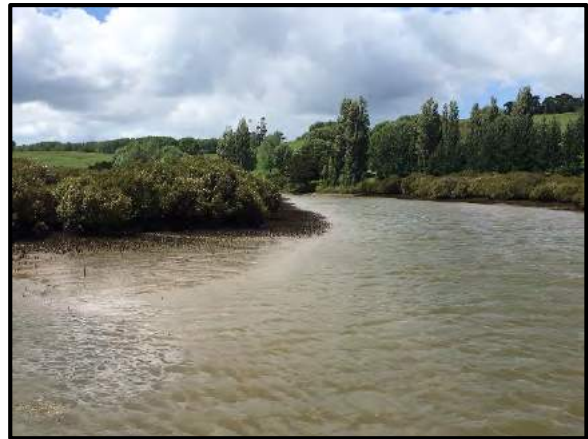
Photo 8: Wairau River, near Otamatea High School. Note the young Holocene alluvial soils to the left of the photo.

Holocene alluvial deposits are mapped near the mouth of the Wairau River in the north-eastern end of the study area (Photo 8) and along the low-lying valleys near the North Auckland Line (NAL) in the western end of the study area (Photo 9). Pleistocene alluvial deposits form elevated terraces adjacent the Holocene alluvial deposits in both of these regions and along the Wairau River. The Pleistocene deposits to the west underlie portions of State Highway 12 and the NAL, and appear to be a preference for commercial development, as they form flat, slightly elevated landforms (Photo 9). Pleistocene alluvial deposits observed near the Wairau River, south of Maungaturoto Bowling Club, between the river and Bickerstaffe Road, appear to be failing at approximately 1V:3H, or about 18.4 degrees (Photo 10). This observation is generally consistent with slope performance reported by others (GNS 2009, T+T 2006 and 2008, and Auckland Council 2017) and supports our assessment of slope instability in Section 14.4.

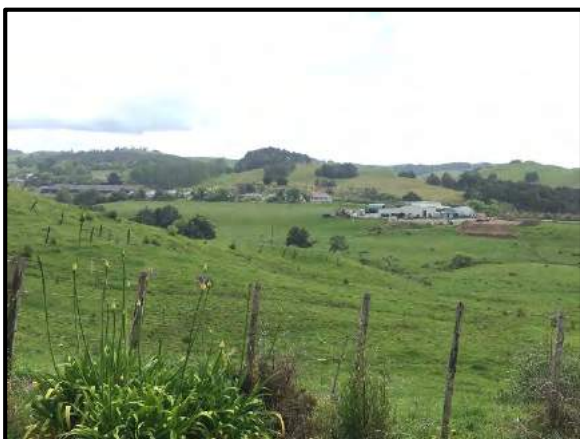
Photo 9: Young Holocene Alluvium within the low laying drainage and a raised Pleistocene alluvial terrace above it. Note that roading and urban development appear to be targeting this deposit.

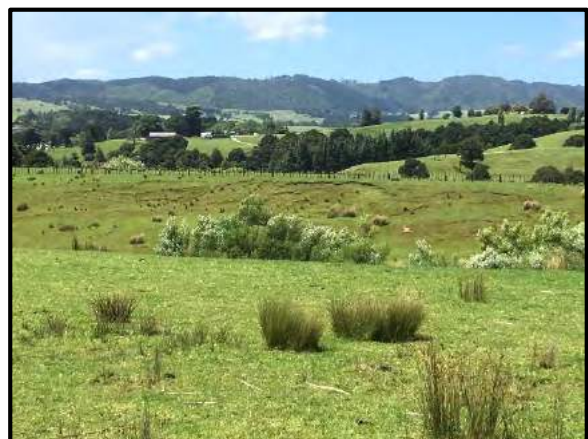
Photo 10: Elevated alluvial terraces failing at approximately 1V:3H angle.

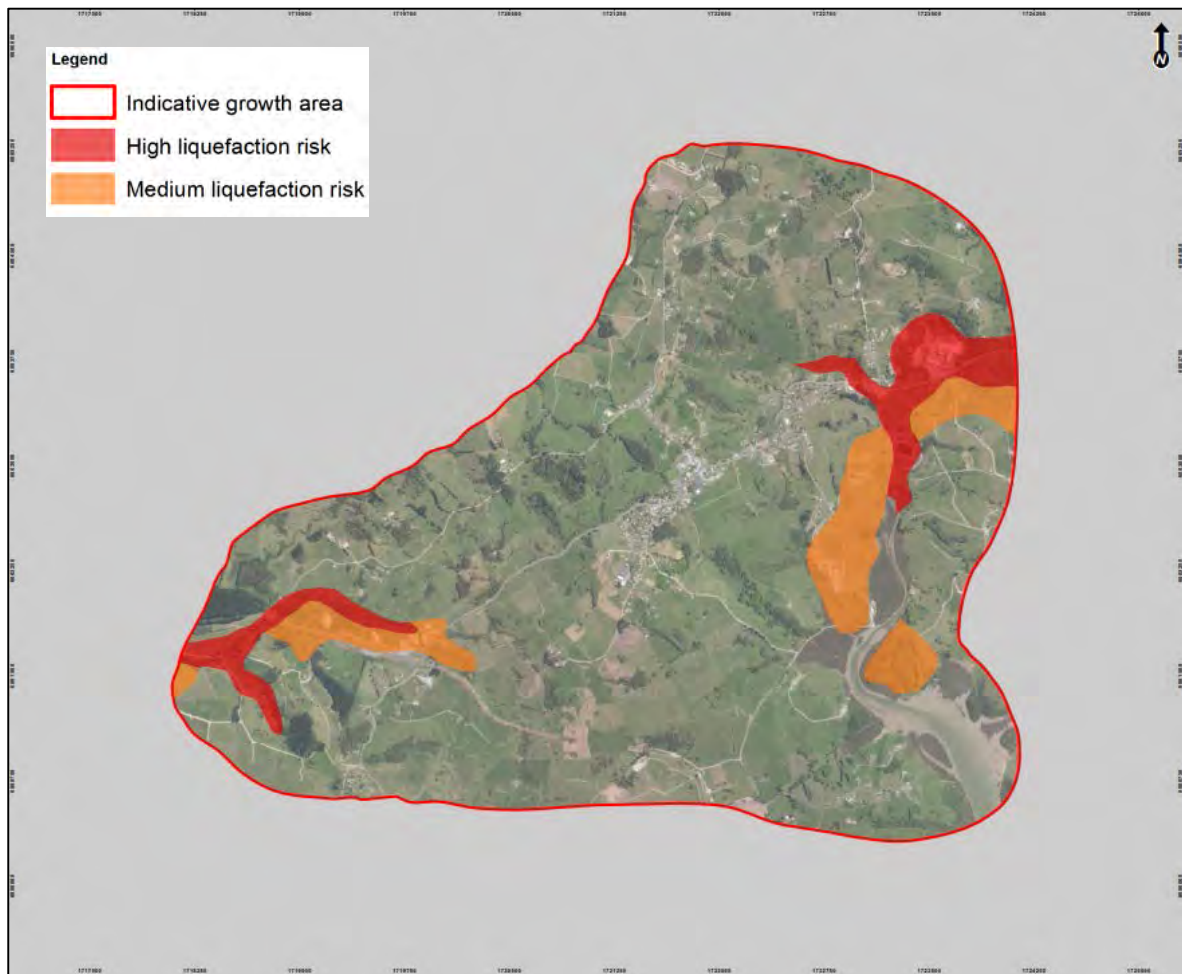
Figure 7: Liquefaction and Lateral Spread Susceptibility Plan

We consider these areas to have a potential to experience liquefaction under SLS conditions. Due to the granular nature of these soils and expected high groundwater, we consider the liquefaction and lateral spread potential of the Holocene Alluvium to be high.

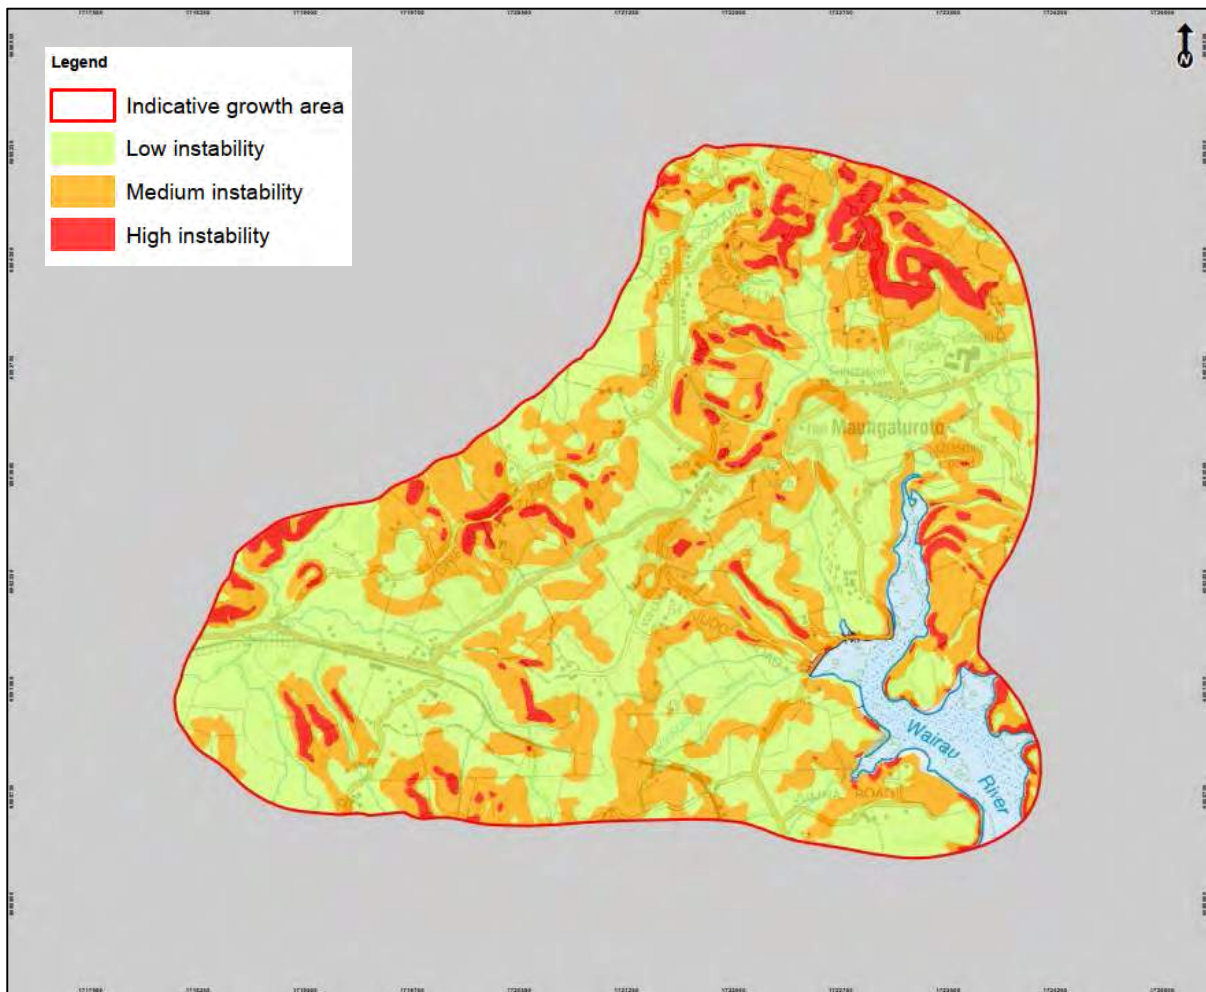
Figure 8: Slope Instability Potential

The slope profile ranges have been applied to the LiDAR contour and elevation data to generate the Slope Instability Potential plan presented in Figure 8. It is important to note that the “Low Instability Potential” category does not imply that instability will not occur on these slopes, particularly where underlain by Northland Allochthon strata. Rather, some of slopes may have historically failed, which has resulted in the flatter slope angles observed today. Changes to the equilibrium of a slope through some combination of land modification earthworks, fill or building loading, or introduction of water, can trigger reactivation of previous landslides on any slope.

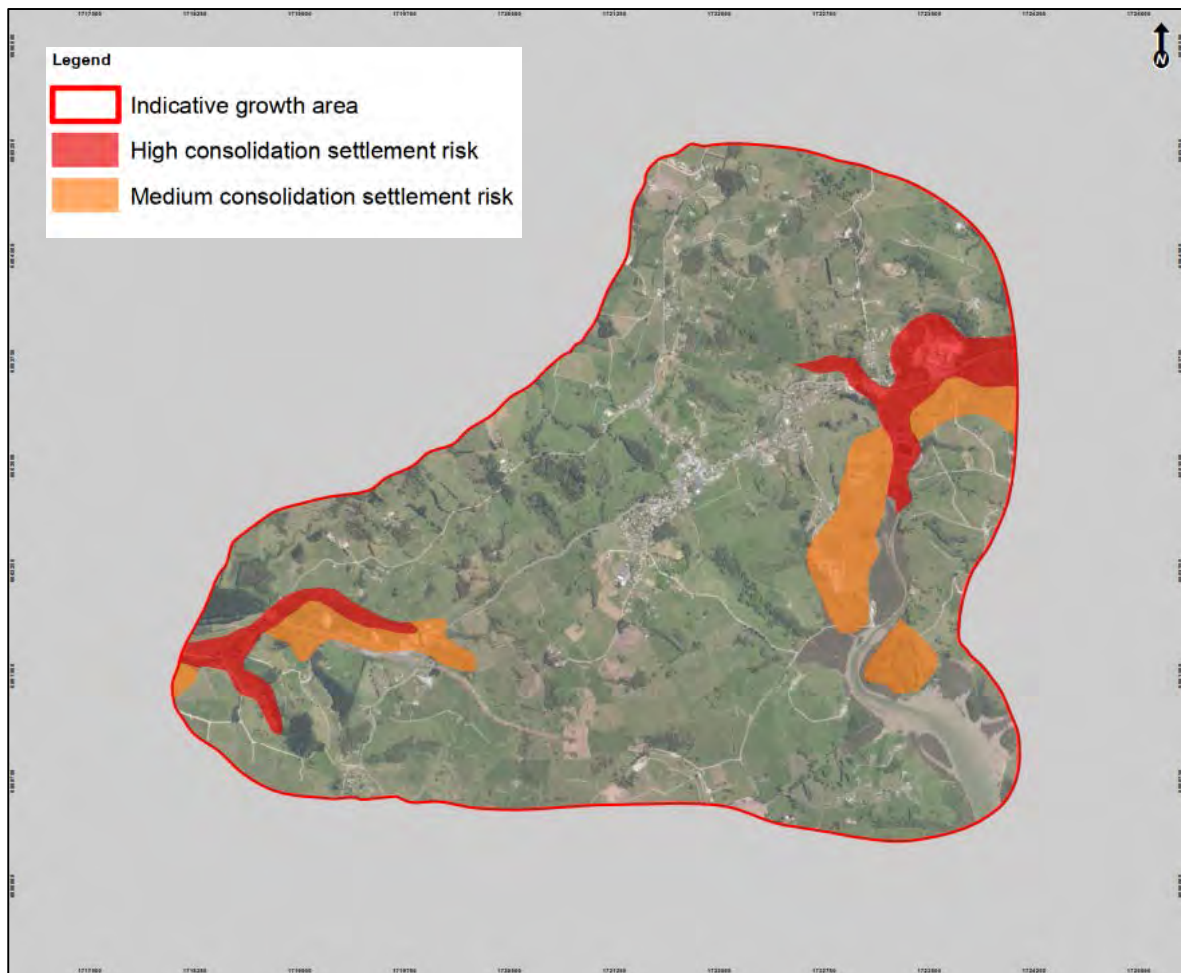
Figure 9: Settlement Susceptibility Plan

Given the likely presence of organic material and soft clay layers, we consider these areas to have a high potential to experience consolidation settlement under loading.

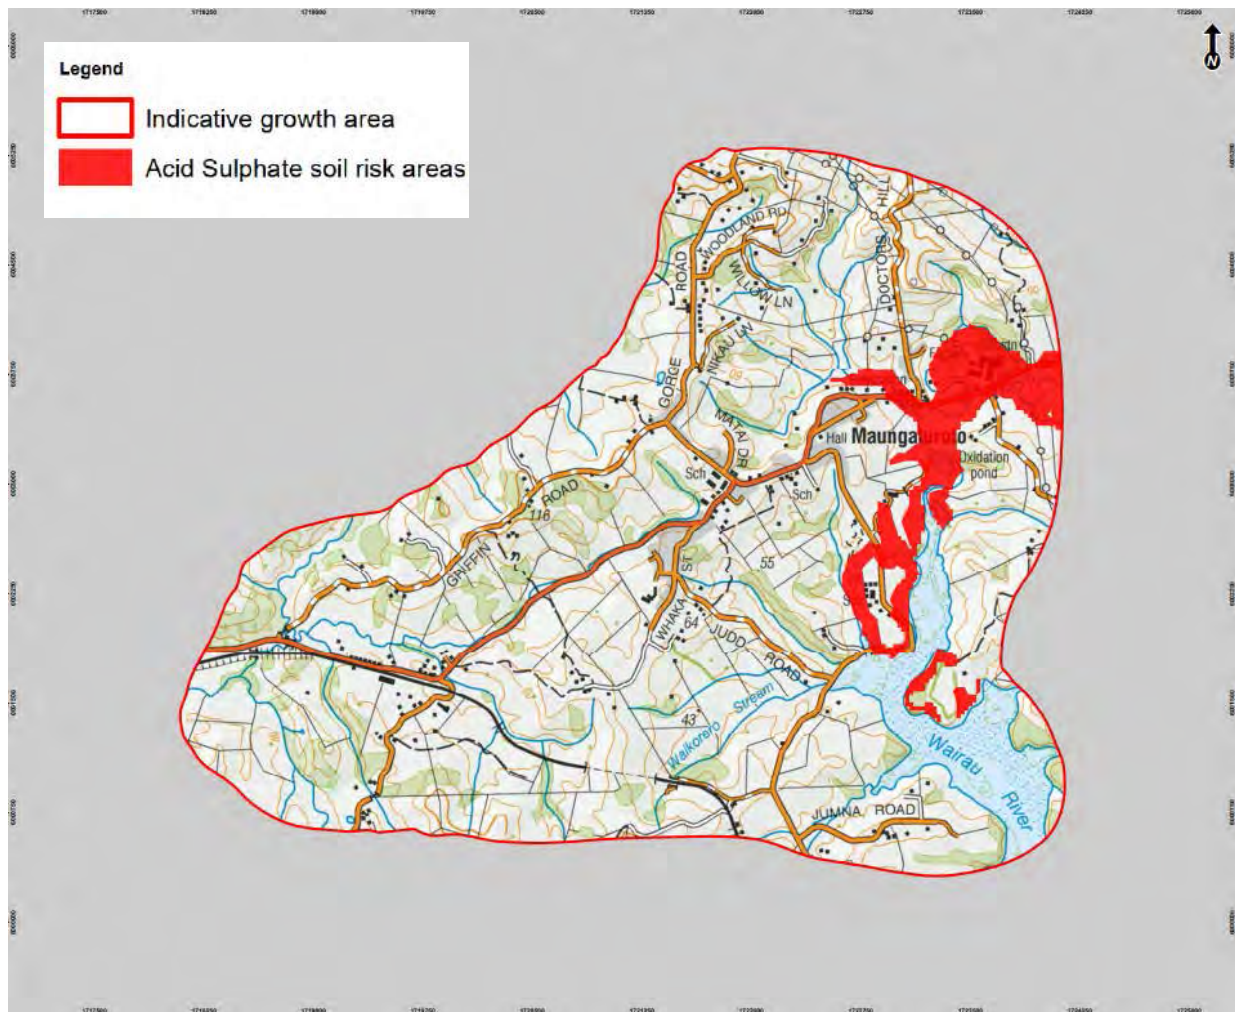
Figure 10: Acid Sulphate Soil Risk Plan

Discussion on risk levels and investigation methodology are provided in Kaipara District Council's Acid Sulphate Soils Policy Basic Planning Guide.

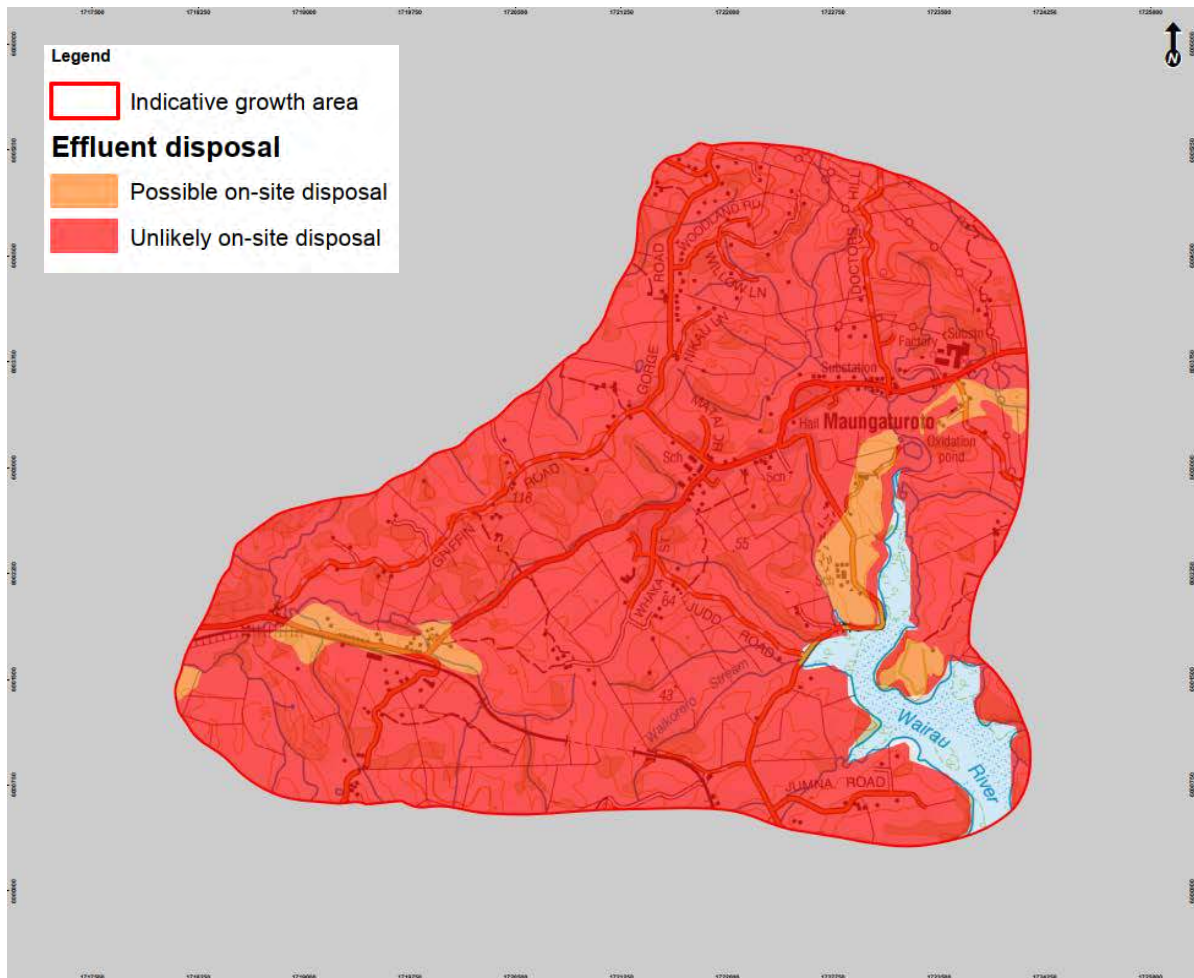
Figure 11: On-Site Effluent Disposal Potential Plan

Due to its low-lying topography, typical near-surface groundwater table, and mandatory setback requirements from clean water sources, Holocene Alluvium has low effluent disposal potential and has been mapped as unlikely.
