NES Assessment (Contaminants in Soils to protect human health)

Preliminary Environmental Site Investigation

68 Molesworth Drive
Mangawhai Heads

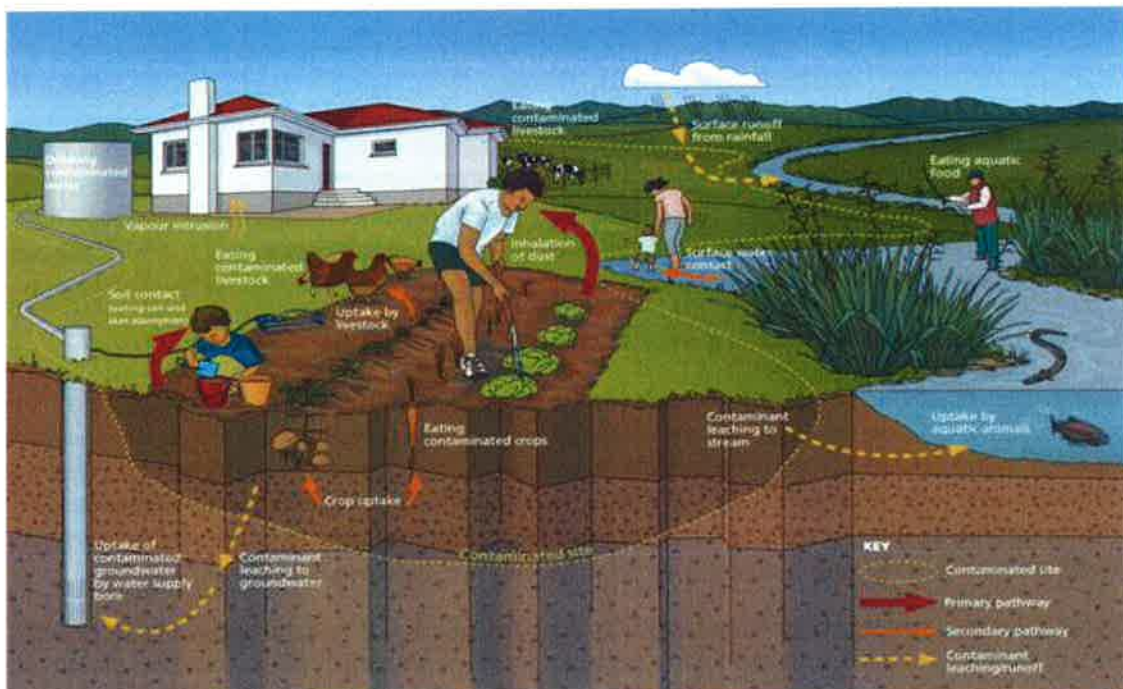
Diagram 1: Pathways by which contaminants in the soil can affect human health

A contamination conceptual site model consists of three primary components to allow the potential for risk to be determined, these are:

- Source of contamination;
- Pathway to allow the contamination to mobilise; and
- Sensitive receptors which may be impacted by the contamination.

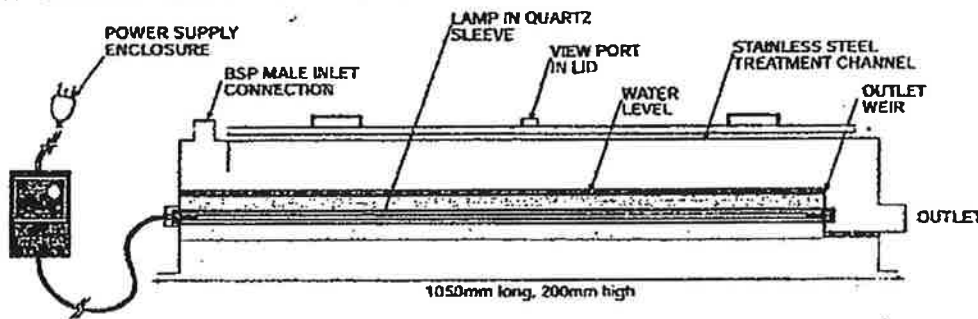
Channel Models (C1 and C1H)

These units feature a compact single lamp design with lamp viewing port and audible lamp failure alarm. Steriflo C1 systems are intended for lower flow applications such as single dwellings or small package wastewater plants. The channel is 316L stainless steel and is suitable for outdoor use. The control

The channel includes an inspection window and level control weir.

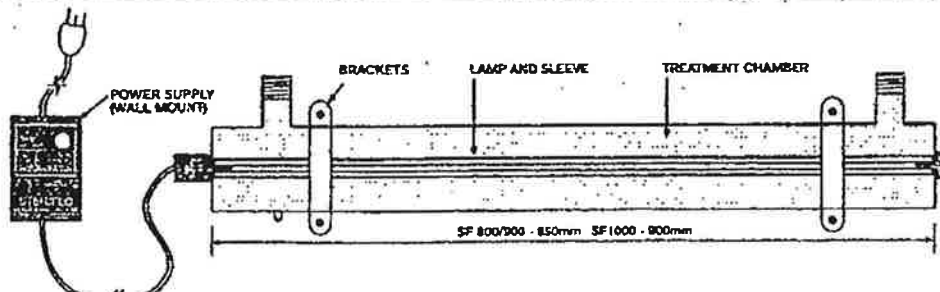
Pressurised Chamber Models (SF Series)

In wastewater systems that are pressurised for irrigation purposes or recycling, or if lack of space requires a vertical installation then pressurised treatment chambers are appropriate. This avoids repumping which may be required with a channel system. All models use short (840mm) UV lamps resulting in compact installations. Disassembly for cleaning of quartz sleeves is simple but consideration should be given during installation to valving for isolation and depressurisation of the treatment chamber for service.

Using a compact single lamp design SF models are intended to deliver performance at an economical price. These units use lamps proven in many hundreds of installations. Treatment chambers are 304 stainless steel with the option of black polypropylene. Standard features include a lamp failure alarm with the option of remote alarm contacts and viewport (not polypropylene models).

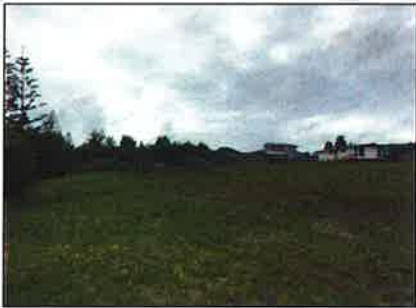
Photo 1: South west of stockpiles, facing north east

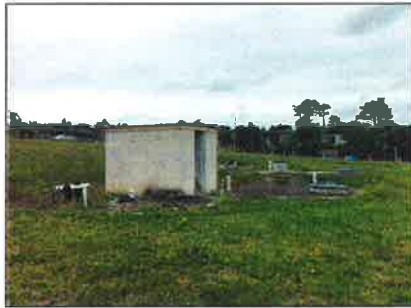
Photo 2: Former wastewater treatment plant

The wastewater infrastructure was decommissioned in 2010, after the Mangawhai Community Wastewater Scheme (MCWWS) was officially opened. The driplines have been removed and the tanks cleaned out. The tanks remain in place.

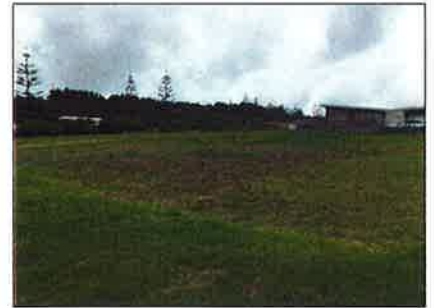
Photo 3: Former wastewater disposal area

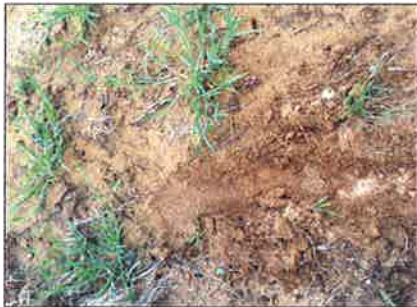
Photo 4: Material in stockpile 1

Earthworks undertaken as part of the subdivision and development of the land surrounding the site towards the east and south east appears to have generated excess spoil, which has been placed in a stockpile in the northern corner of the site between 2006 and 2010 (refer to Section 3.4). It is considered unlikely that the material in the stockpile contains concentrations of contaminants (if any) that would present a risk to human health under the commercial land use exposure scenario. Two smaller stockpiles, showing no indications of significant contamination, were also observed in the northern portion of the site.

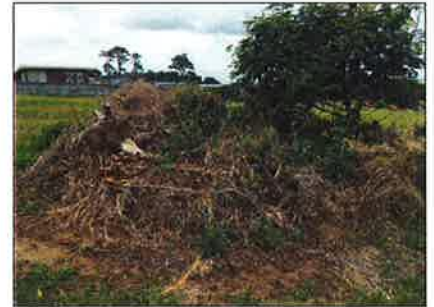
Photo 6: Material in stockpile 3
