MANGAWHAI COMMUNITY PARK WETLANDS HYDROLOGY ASSESSMENT

PREPARED FOR KAIPARA DISTRICT COUNCIL

04/07/2019

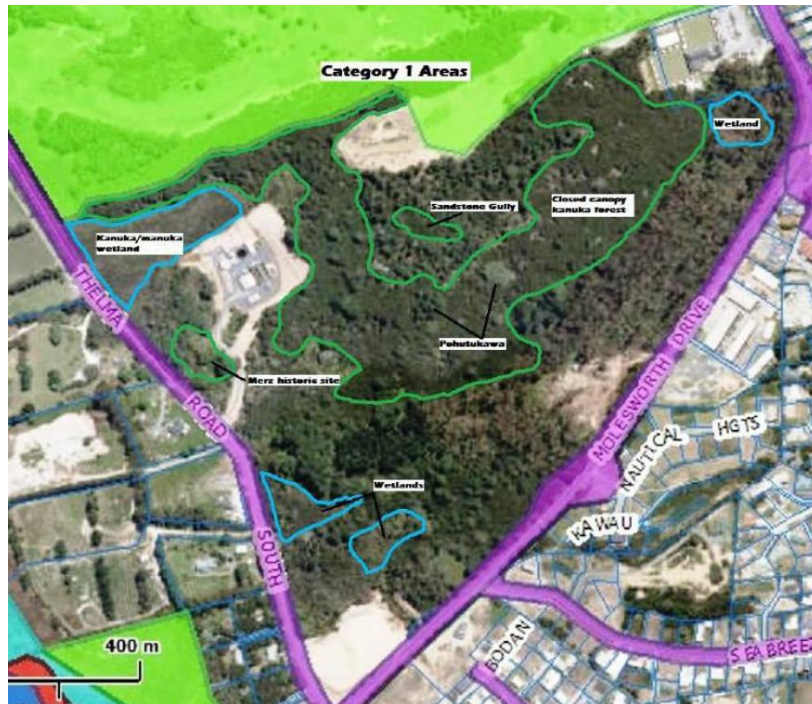
Figure 2. Mangawhai Community Park Category 1 Areas from the Mangawhai Community Park Master Plan

Most of the Park is steep or undulating creating lower lying hollows that have developed into wetlands or soakage areas. The high value ecological features of the park are identified in the Mangawhai Community Park Master Plan are shown in Figure 2 below which is sourced from that document.

- Upstream of the existing Ambulance and Fire station there is a bushed area with small rises and depressions which includes the upstream wetland as referred to on the Mangawhai Community Park Master Plan (refer to Figure 2). Water normally ponds in these depressions and then soaks into the ground, there is no overland flowpath out of these depression areas.

- The catchment of the Ambulance and Fire station catchment consists of the area upstream of the MAZ including the area referred as a wetland in the Mangawhai Community Park Master Plan (refer to Figure 2). It is defined by Molesworth Drive and Mangawhai Golf Club and it extends to the high point at Heather Point in the intersection with Moir Point Road as shown in Figure 11.

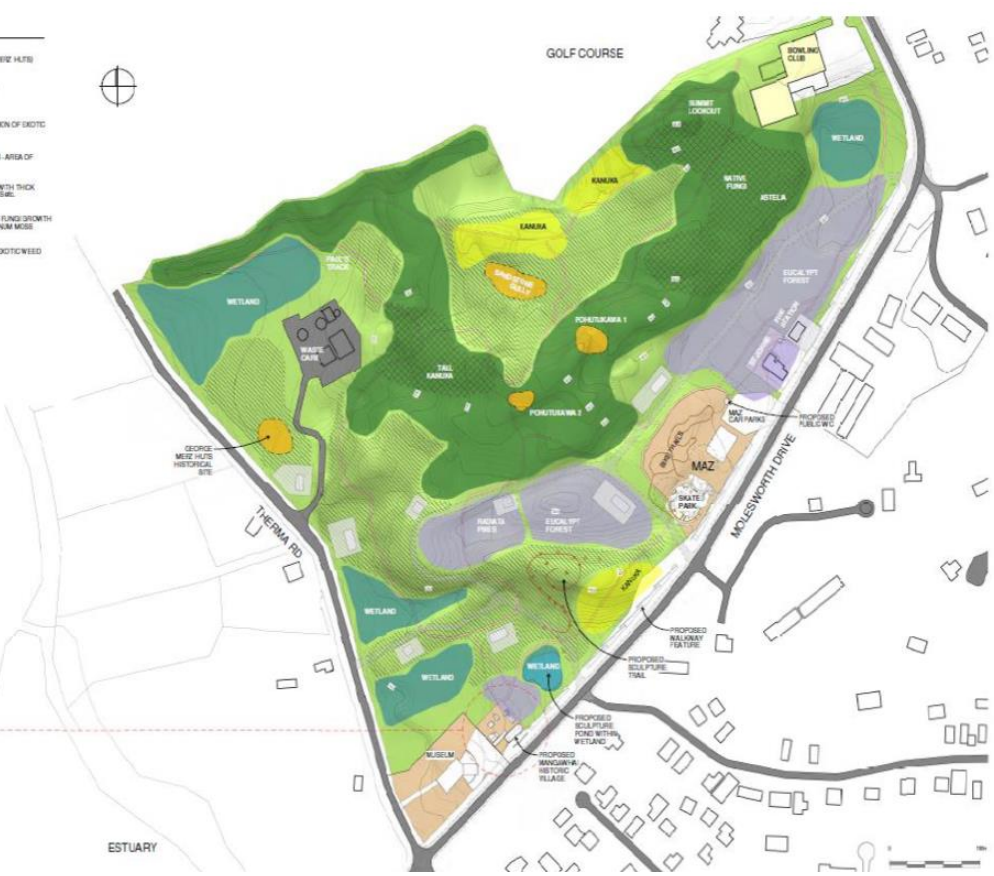
Figure 3. Mangawhai Community Park Master Plan Drawing, from the Mangawhai Community Park Master Plan

The Mangawhai Community Park Master Plan, shown in Figure 3, is to create a built precinct that engages with the Park-lands and has the potential to become a destination in itself providing amenity, recreation, entertainment and locations of cultural and natural significance that support long-term community sustainability.

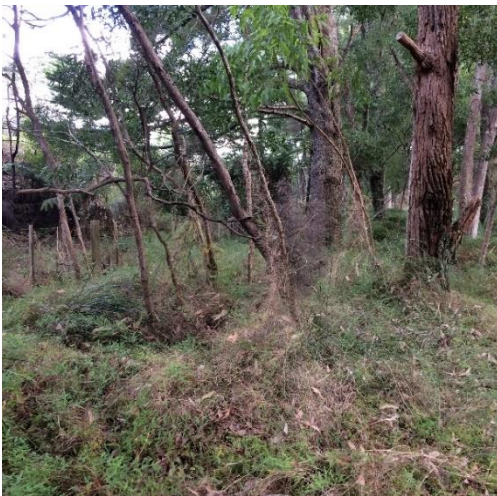
Upstream wetland

- Retain existing depressions and bush area upstream (uphill) of the Fire Station development.
- Prioritise the cycleway bridging over depressions with low suspended paths.
- Enhance existing storage areas and protect them using non-intrusive construction methodologies for the shared path such as low suspended bridges.
- Provide, formalise and protect infiltration and soakage areas behind the Ambulance and Fire Stations. Where these areas cannot be protected allow for overland flowpaths from them to protected soakage/infiltration areas and align the cycleway to minimize impact on it from ponding and overland flow.

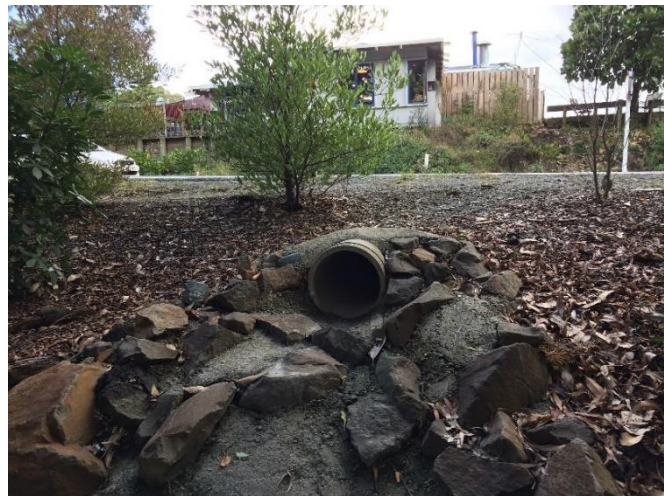
- There are three existing stormwater discharges from Molesworth drive to the catchment, one of them adjacent to the Molesworth Drive intersection, one on 198 Molesworth Drive and one in front of the Fire Station. The stormwater discharge in front of the Fire Station site has been extended to now discharge to the rear of the site. Photos from the site visit of the area are shown in Figure 4 and Figure 5.

198 Molesworth Drive outlet to existing hollow area

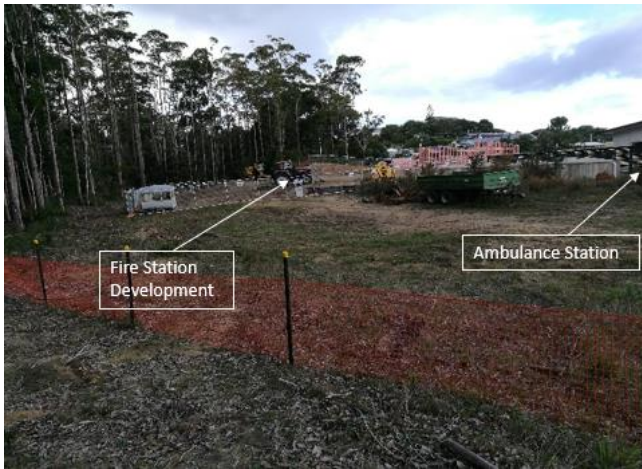
- Drainage in the region of the Ambulance and Fire stations has historically been into a depression at the rear of the sites and then via soakage into the sands. The recent construction of these two facilities has increased the impervious surface coverage and partially filled the depression. The consequence of these works has been to reduce storage and soakage ability of the area which will lead to future extended ponding and possibly flooding of the proposed shared path. Photos from the site visit of the area are shown in Figure 5.

Existing Ambulance and Fire station filled area on the back of the site looking up towards the intersection between Molesworth Drive and Heather Street

- The construction of the Ambulance and Fire Stations has increased the impervious surface coverage and partially filled the pre-existing depression. The consequence of these works has been to increase flow rates and volumes, reduce storage and soakage ability of the area which will lead to future extended ponding and possibly flooding of the area and the proposed shared path.

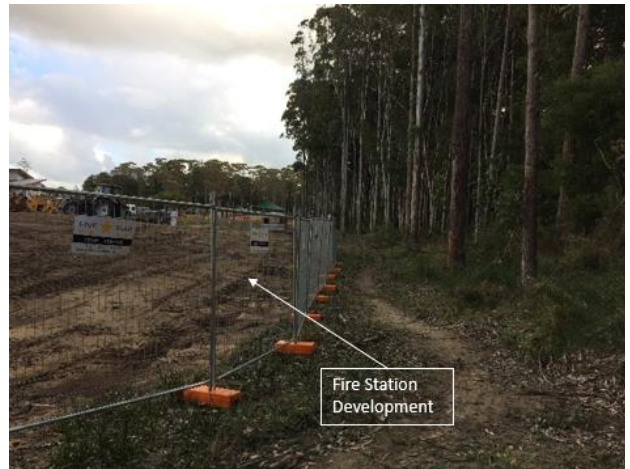
- Further development is proposed to be carried out to the rear of the Fire station site. The intention of the development is to clear the Eucalyptus Gum trees and further fill the depressions occupied by the trees using fill from the high ground adjacent to the carpark. This filling will increase the stormwater to be disposed of in the affected area and reduce the storage and soakage ability of the area. As described above there is no overland flow path or pipe outlet currently available to alleviate flooding in the area.

Eucalyptus Gum trees to be cleared on the back of the new development on the Fire station site looking down in the direction to the MAZ area

- Further proposed development behind the Fire station site with the intention of clearing the Eucalyptus Gum trees and further filling the depressions occupied by the trees will increase the stormwater to be disposed while reducing the storage and soakage ability of the area.

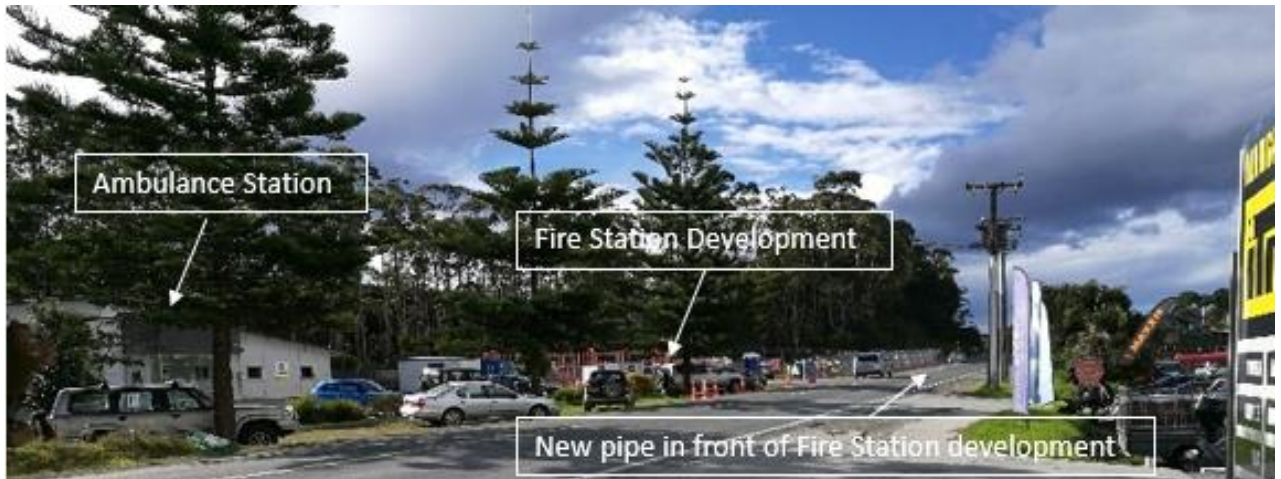
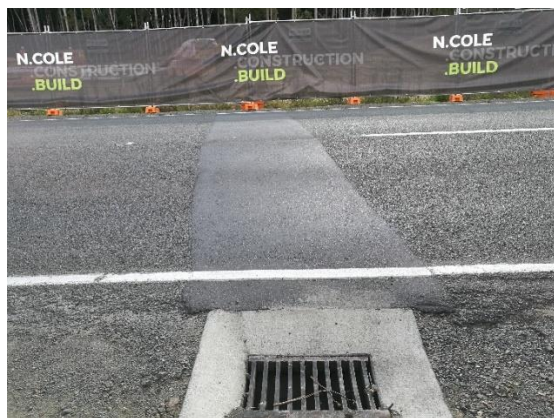
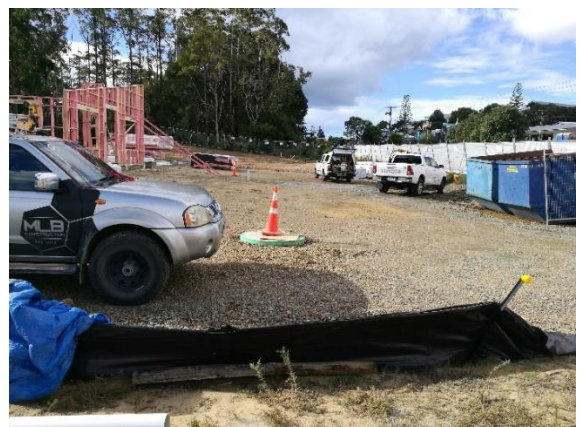
Figure 5 Ambulance and Fire Station Site Photos

New pipe crossing Molesworth Drive in front of Fire Station development running through the Fire Station development site and discharging to a depression at the rear of the site.

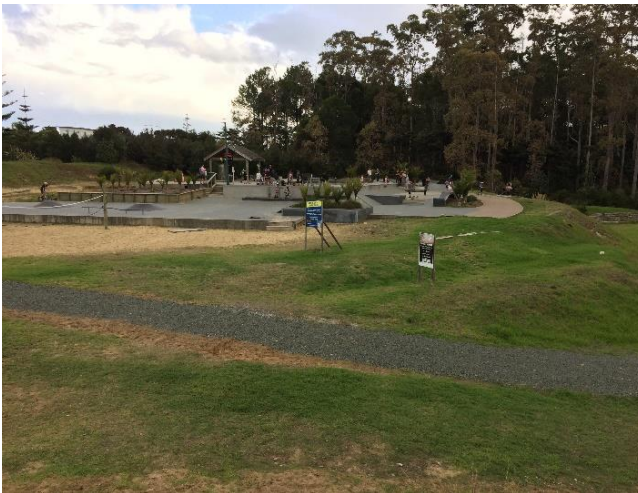
- The whole MAZ area drains down to a low point to the Southwest.
- There is no overland or piped discharge from this area, stormwater has historically soaked into the sandy soils.
- It is possible that the low point drains via groundwater flow to help recharge the Museum wetland, but this has not been confirmed as part of this report.
- Through the development of the MAZ some of the local storage and soakage in this area has been paved reducing the ability for infiltration into the ground.
- The existing carpark is proposed to be resealed, which is likely to increase the volume of stormwater runoff to be managed.
- The proposed shared paths will run through near the low point to the Southwest of the catchment, putting it at future risk of inundation.

Existing MAZ area recontoured and paved draining to the low point on the Southwest

- Throughout the development of the MAZ area, the local storage areas have been paved through the development of the MAZ area reducing the ability of infiltration into the ground.
- Flows from much of the MAZ area are flowing to the depression in the southwest, with no current plans for how to manage these flows, what the extent of ponding may be and how this will affect the proposed cycleway alignment.
- Lack of an overland flowpath from the children's playground.
- Proposed improvements to and sealing of the carpark area, with limited options for the disposal of stormwater and no overland flowpaths from the area.

- Consider a treatment train type approach for runoff from the carpark, including primary and secondary treatment, soakage and then overland flow to the low point at the southwest of the MAZ area.
- Formalise and protect an overland flow path to the Southwest of the MAZ area.
- Retain and formalise the existing ponding/infiltration area to the Southwest of the MAZ area and identify possible maximum flood levels in this area.
- Develop the cycleway route considering the ponding in the low area including route selection and possible bridging over the area subject to ponding.

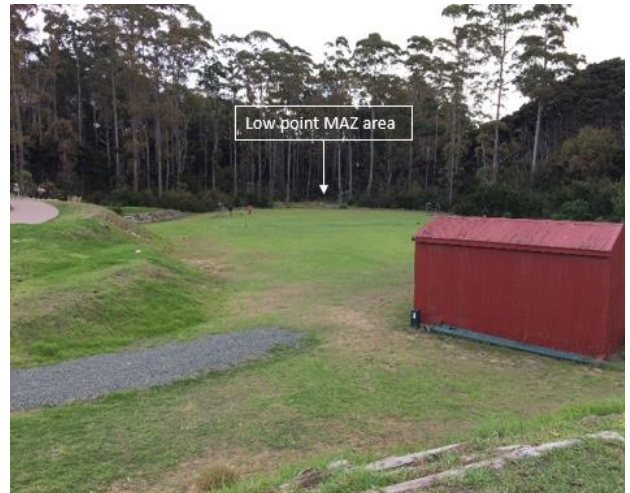
Low point on the southwest of the MAZ area

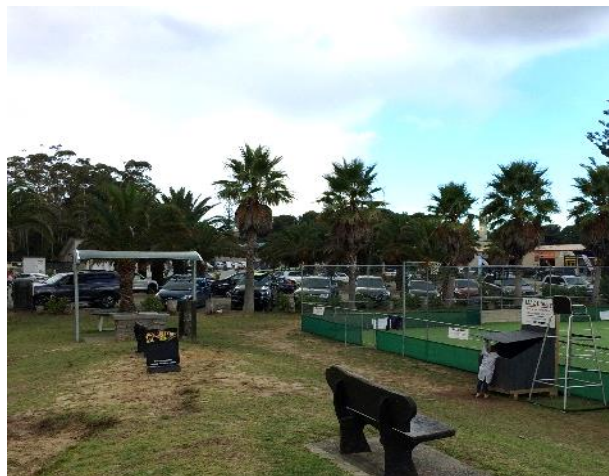
Existing MAZ carpark to be resealed

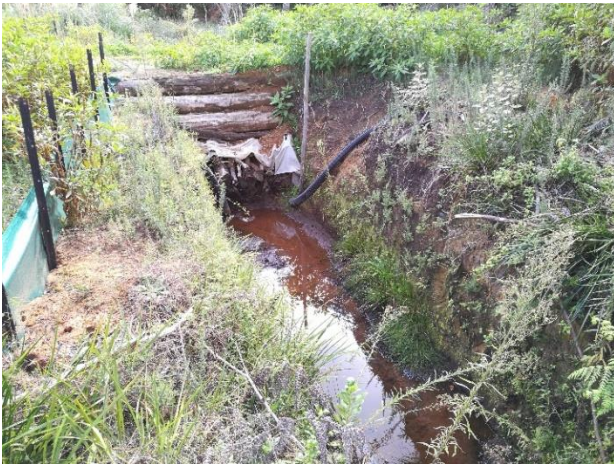
- There is a recently installed fascine drain¹ at the outlet from the upstream wetland to the lower wetland which will restrict the extreme flows from the upstream catchment. No overland flow path has been allowed for the upper wetland to drain during extreme flows from this upstream catchment

Fascine drain at the outlet from the upstream catchment

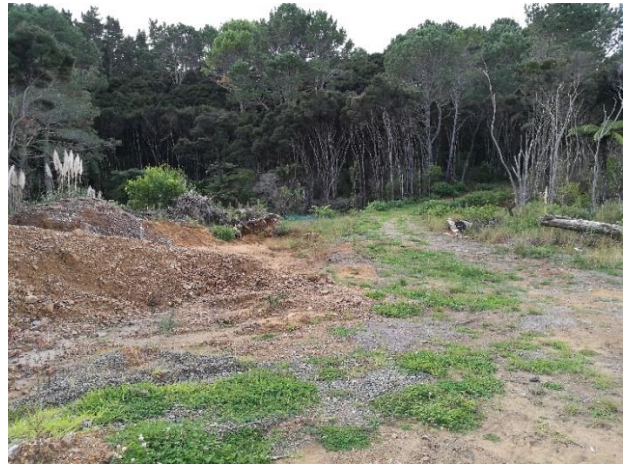
Early shared path works around the Museum area over the fascine drain

- Define no-go areas around the margins of the wetlands for earthworks activities.
- Co-ordinate with transport and stormwater engineers to confirm the total future catchment to be passed through this area.
 - Calculate the peak flows to be passed through this area.
 - Carry out detailed definition of likely maximum water levels within the wetlands to inform future development.
 - Provide for peak flows to be passed at the fascine drain location. Passage of these flows could either be by modifying the fascine drain to pass flows or to provide and protect an overland flow path across the path at this location. This flow path might for example include construction of a bridge over the overland flowpath to avoid loss of use of the path during or following high flows.

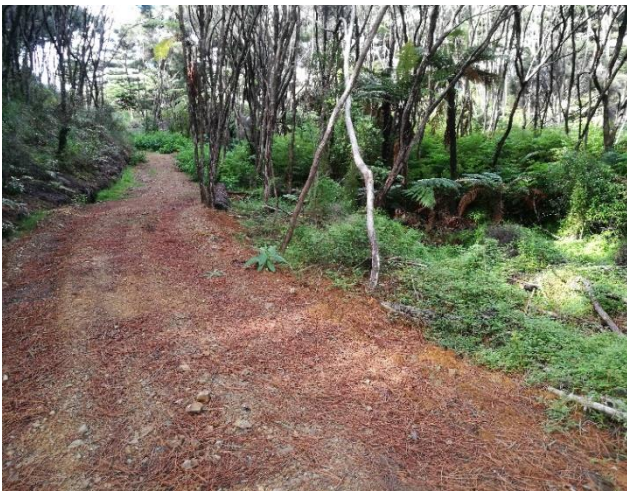
Early works for the construction of the shared paths

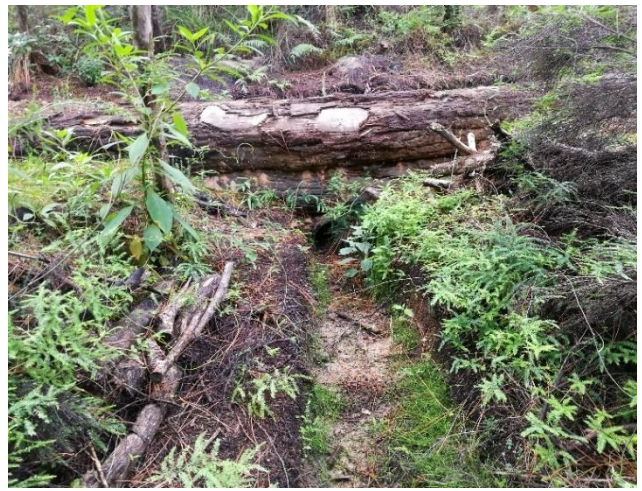
Crossing under the shared path as part of early works

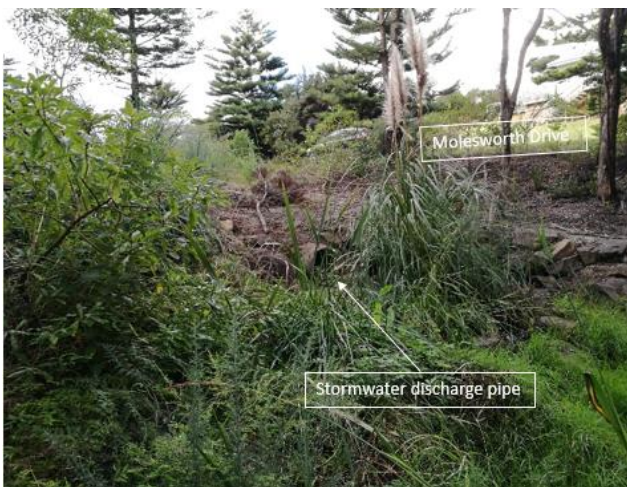
- New pipes draining Molesworth Drive and some of the industrial area have been extended from Molesworth Drive to the Museum catchment area adding stormwater to be passed through the wetland.

Molesworth Drive stormwater discharge

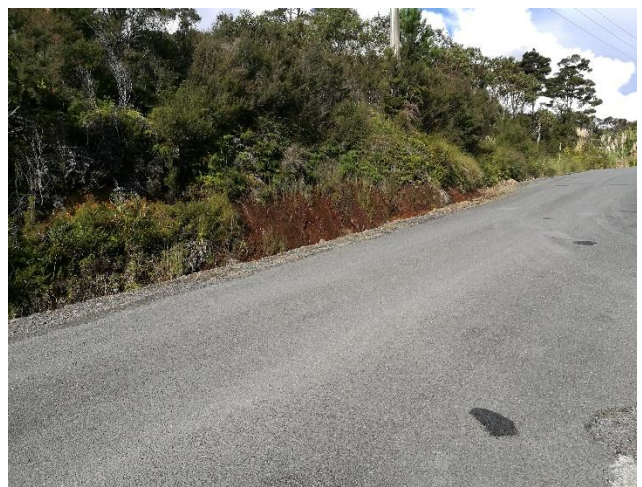
- Existing wetland infiltrates down to Thelma Road and drains away through the existing roadside channels before passing through the road culverts.
- There is a current proposal from the KDC transportation department to connect drainage from Seabreeze Road to the upper wetland.

Outlet from the wetland to Thelma Road

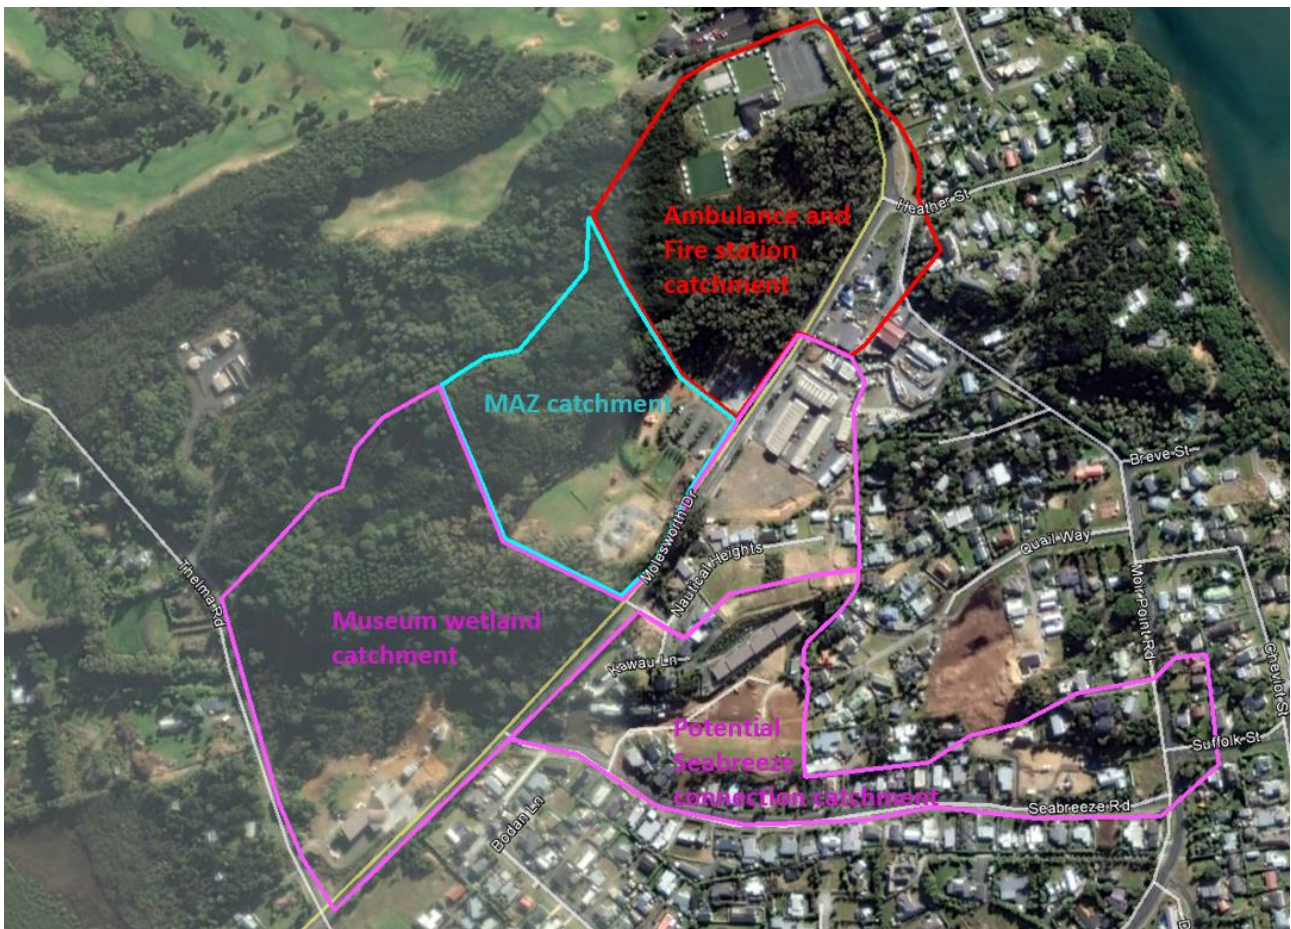
Figure 11 Sub-Catchments Areas

- The MAZ area catchment comprises of the MAZ area itself (including the carpark) and the area from the wider catchment ridge discharging to the MAZ area as shown in Figure 11.

- The Museum wetland catchment compromises the existing wetland catchment itself, the museum and school area in the south corner of the Mangawhai Community Park, the industrial area east of Molesworth Drive and the possible future connection from the residential area east of Molesworth Drive limited by Seabreeze Road and Nautical Heights as shown in Figure 11.
