<b>Meeting</b>	<b>Raupo Drainage Committee</b>
<b>Date</b>	Thursday 16 August 2018
<b>Venue</b>	Raupo Drainage Board Offices – Wharf Road, Ruawai
<b>Time</b>	10.00am

## **Open Agenda**

Project: KAIPARA DISTRICT COUNCIL BOWERGATE-RIUAWAI STOP BANK UPGRADE
Issued For Pricing A	Approval (Revision Date) 2018-02-09	Sheet: OPTION ONE CROSS SECTIONS STN. 758.2 - 1552.7
Design: S. ROTAYORI Drawn: C. HOUTHWAM	Approved: F. RICHTER State: 1100/01 TA1	Project No.: 1-13583.00 Revision: A

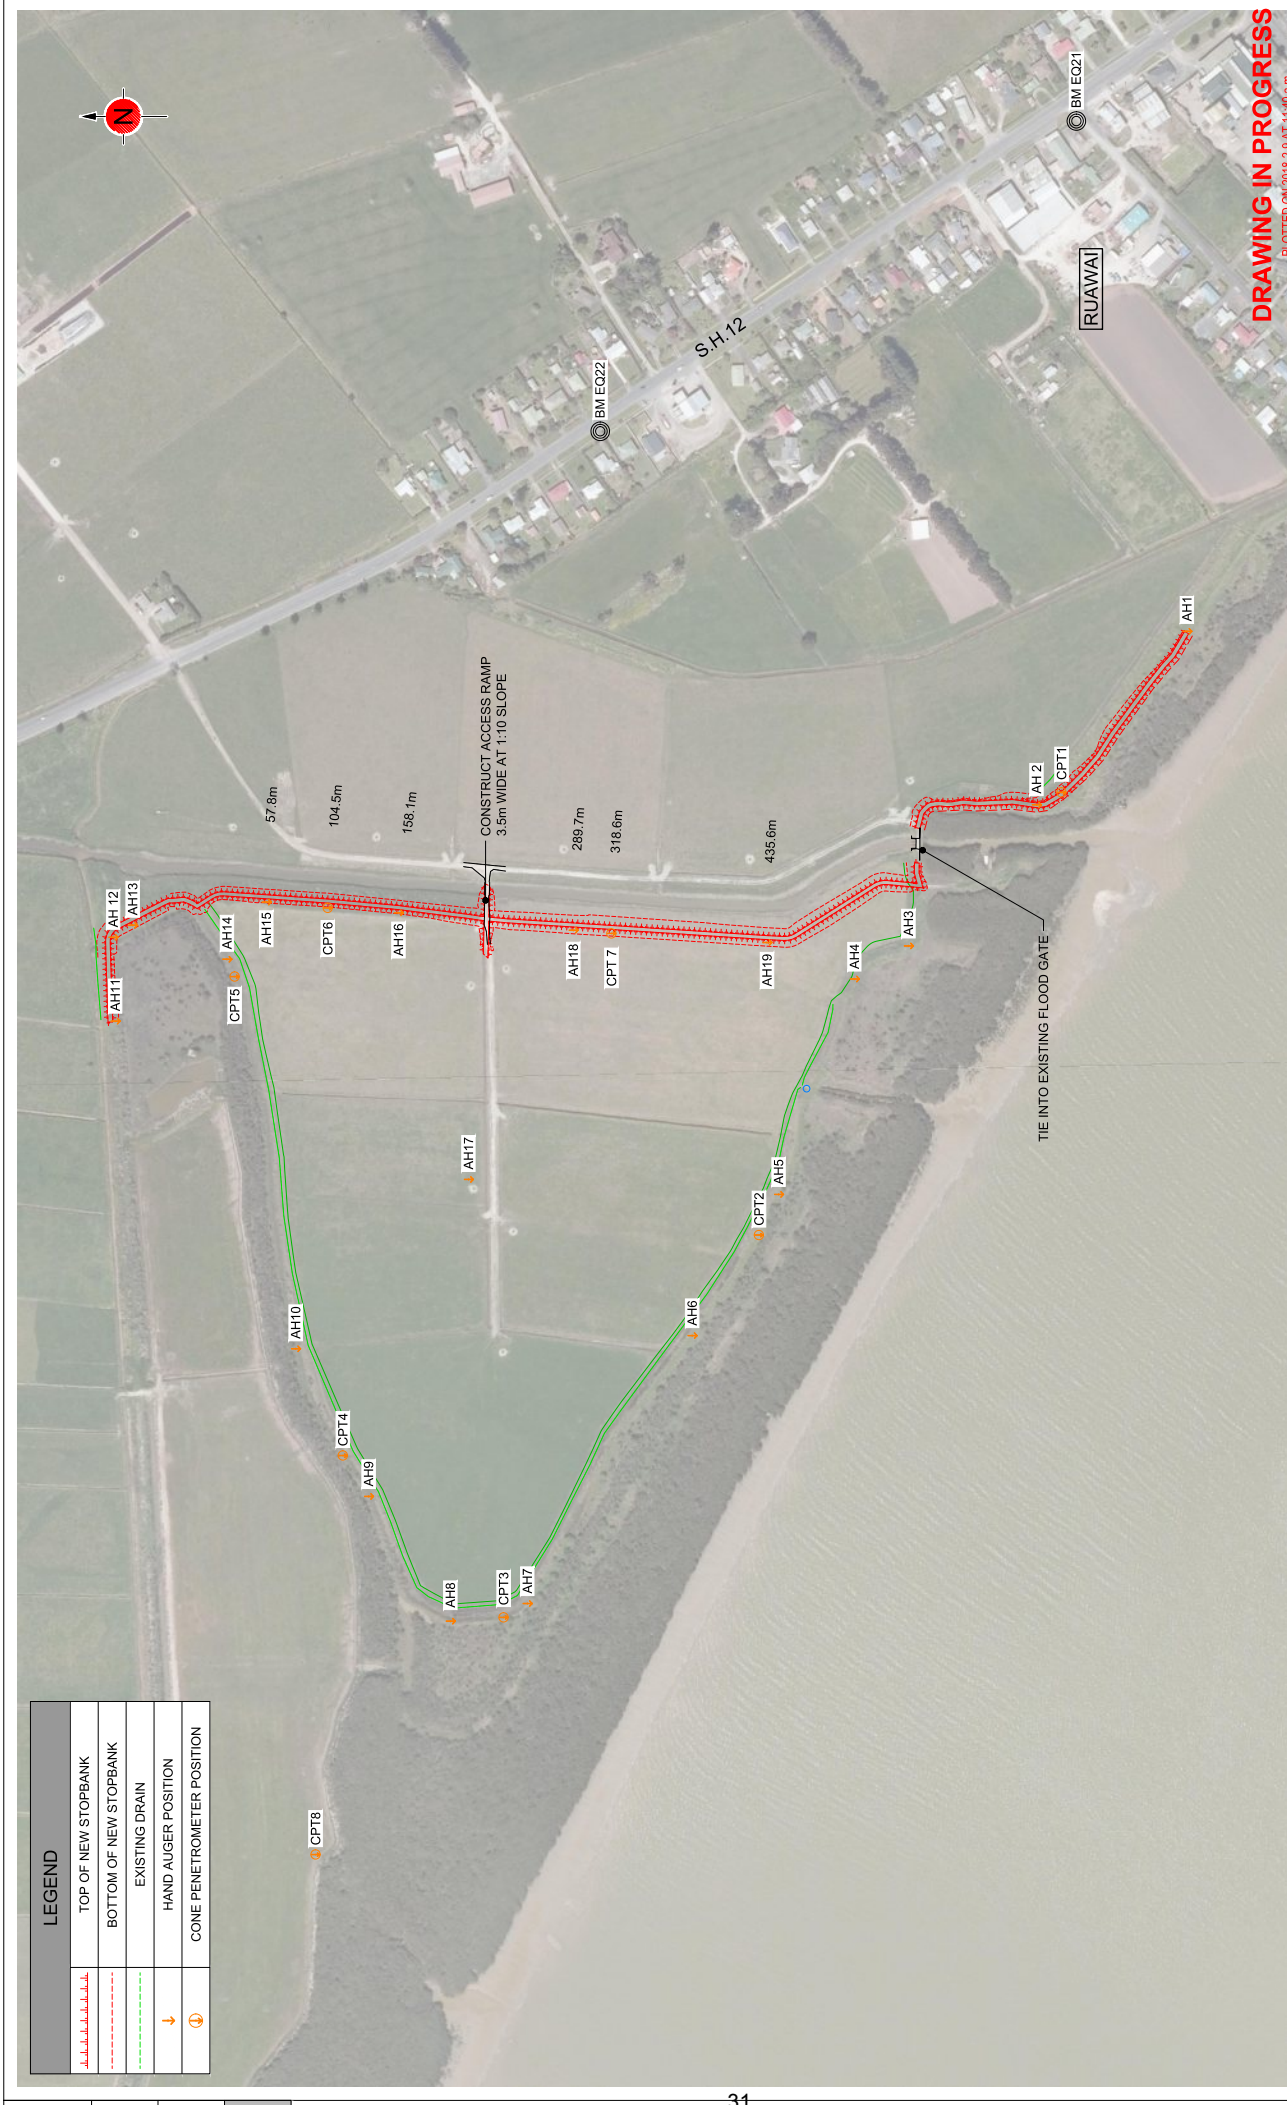
LEGEND	
	TOP OF NEW STOPBANK
	BOTTOM OF NEW STOPBANK
	EXISTING DRAIN
	HAND AUGER POSITION
	CONE PENETROMETER POSITION
