Kaipara District Council

# DETAILED SITE INVESTIGATION

## WASTEWATER TREATMENT PLANT, 2/40 THELMA ROAD SOUTH, MANGAWHAI

22 FEBRUARY 2021

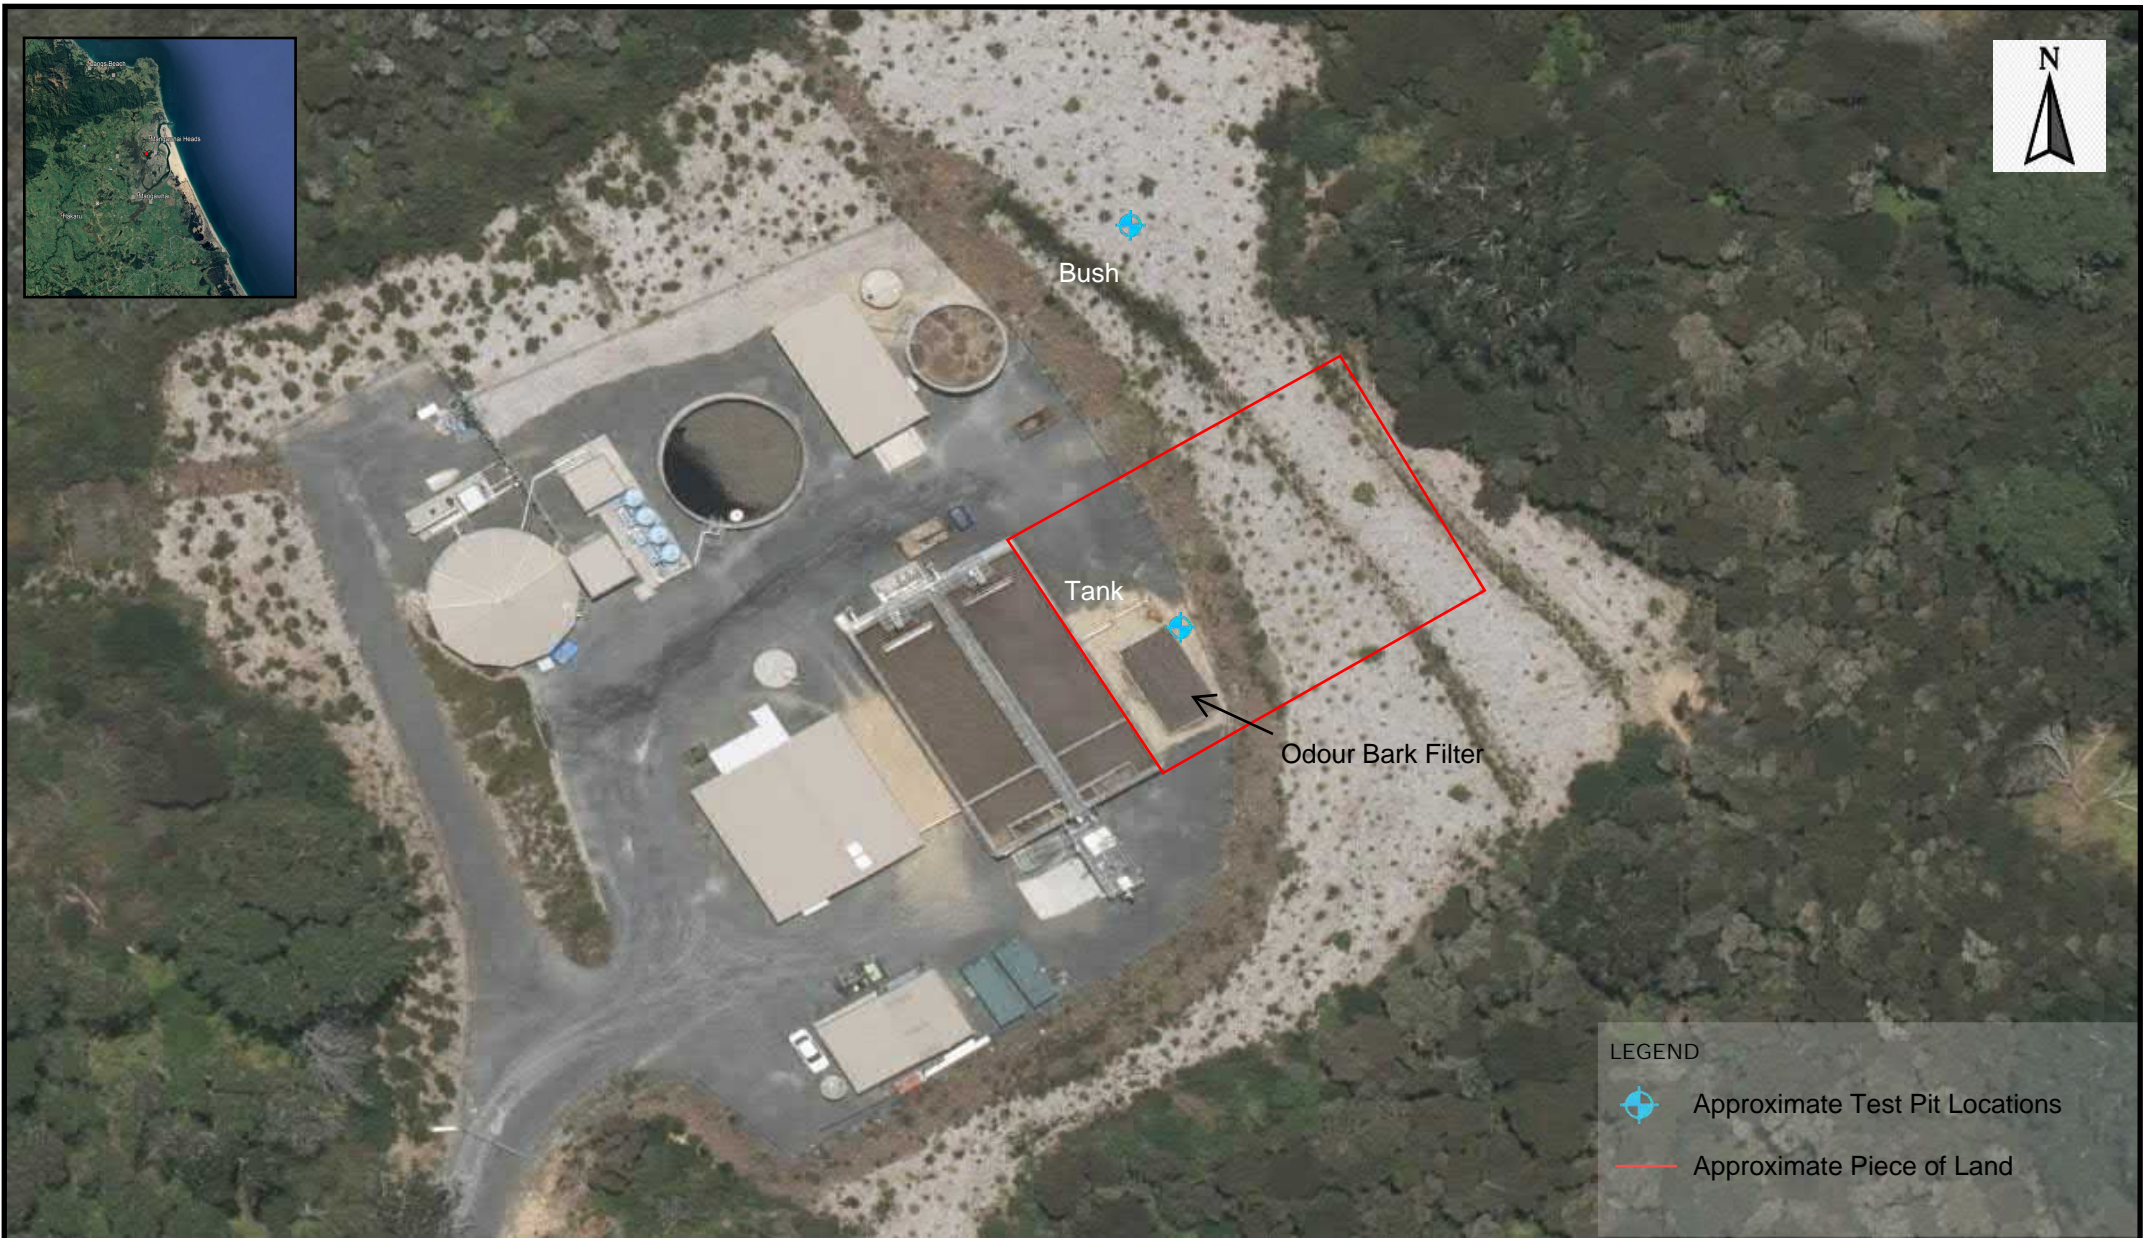
The site is accessed off Thelma Road South, Mangawhai and contains several buildings and tanks of the WWTP operations, located on an engineered level site surrounded by bush. The site identification details are provided in Table 2-1. The piece of land under investigation is the location of an odour bark filter and associated infrastructure, and adjacent scrub hillside to the east beyond the current fence line. The site and piece of land is shown on Figure 1, Appendix A.

The original scope included the collection of samples from two locations within the piece of land with one located between the bark tank and the eastern fence and the other located east of the WWTP within the reinstated scrub hillside. However, the reinstated hillside was overgrown with gorse and Manuka trees preventing access to the selected sampling location. Consequently, a secondary sample location to the north of the original sample location was identified where access was possible. WSP considered this an acceptable variation because the reinstated hillside bank is understood to have been developed at the same time as the initial construction and ground conditions expected to be generally homogenous across the slope. Final sample locations are shown on Figure 1, Appendix A.

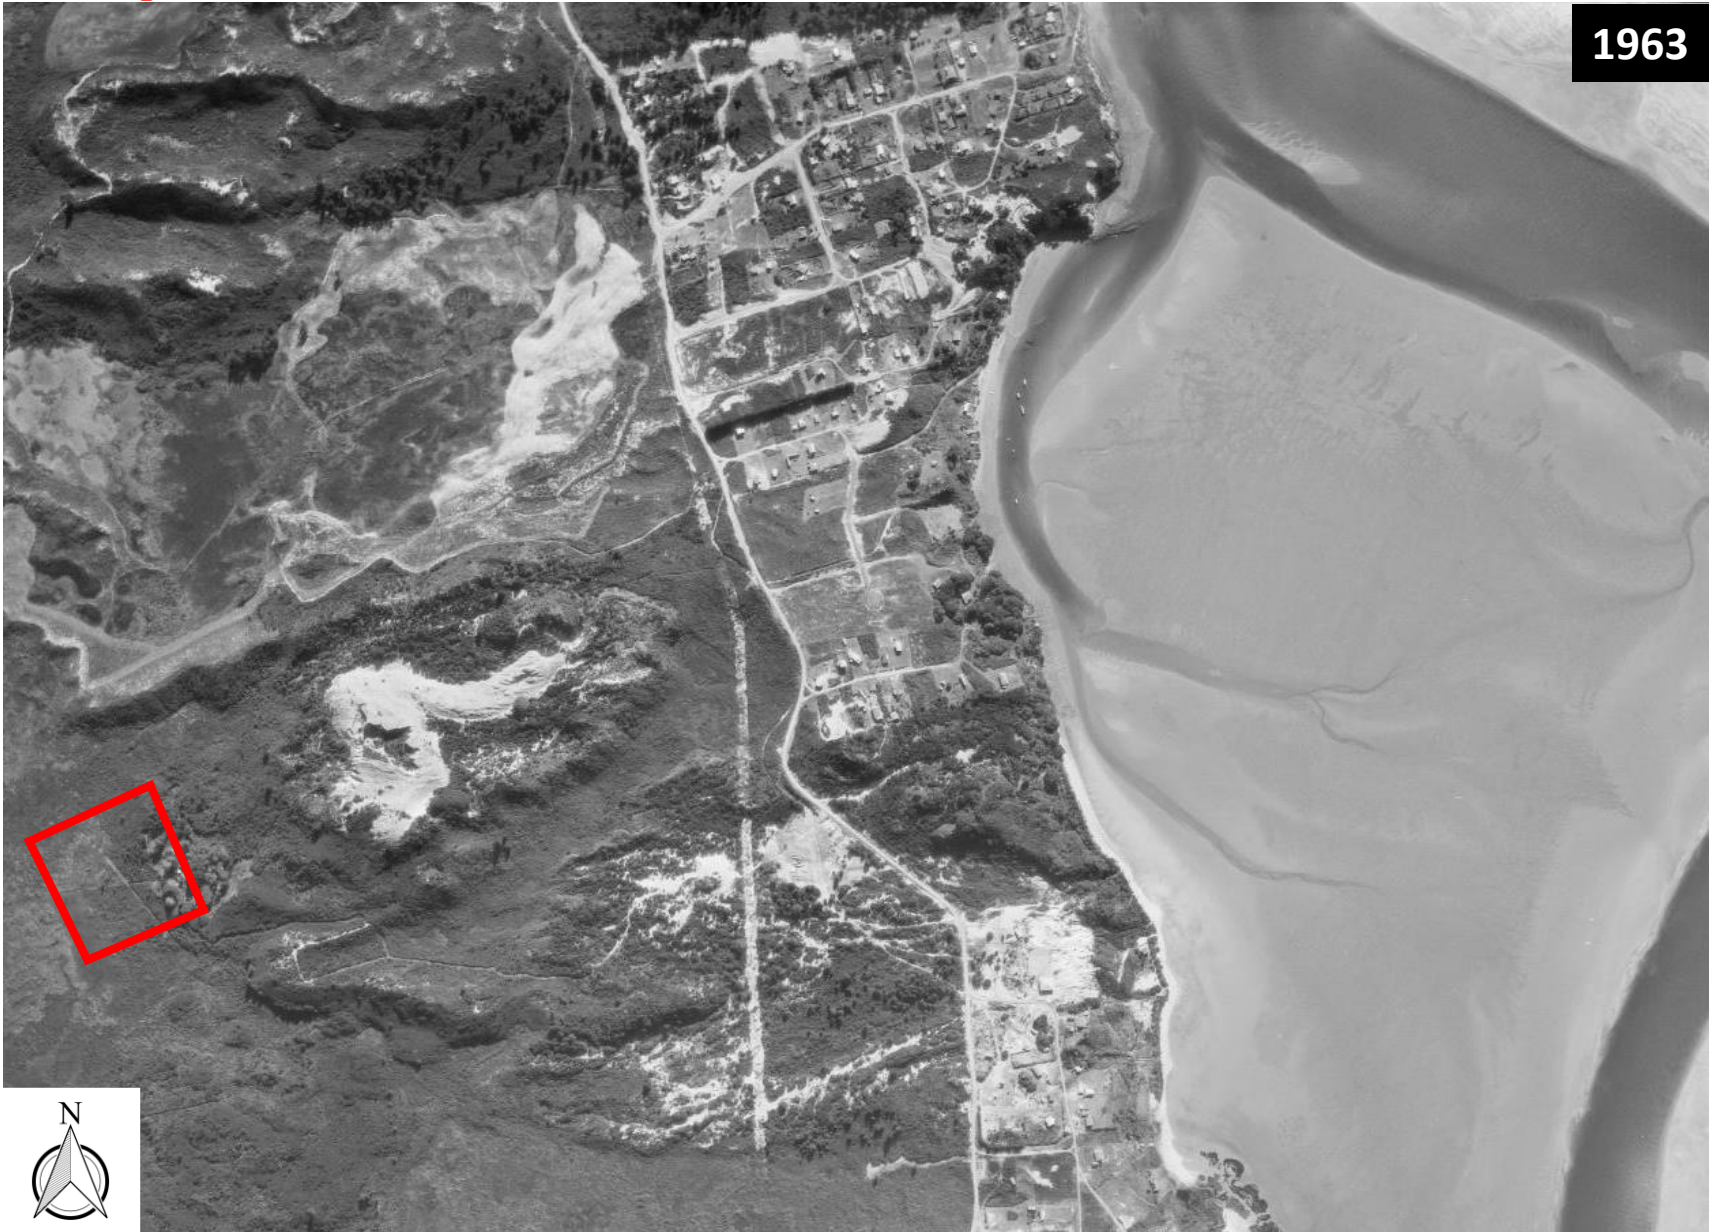
YEAR	OBSERVATIONS
1963 -1966 (Retrolens)	The site is under bush, Mangawhai heads township is 0.7 km to the east.
1977 (Retrolens)	Land 150 m to the west is under pasture, there are forest roads directly south of the site connecting to Molesworth Drive 0.5 km to the south.
1983 -2006 (Retrolens and Google Earth)	No significant changes can be observed from the previous photograph.
2015 (Google Earth)	The wastewater treatment plant has been constructed on the site
2019 (Google Earth)	No significant changes can be observed from the previous photograph
