Meeting	Raupo Drainage Committee
Date	Thursday 15 November 2018
Venue	Raupo Drainage Board Offices – Wharf Road, Ruawai
Time	10.00am

Option 1 (see Fig 1 Appendix A): refers to the remediation of the substandard stopbank on the existing alignment of the stopbank on **SECT 73-75 PT 44 BLK XV TOKATOKA SD.**

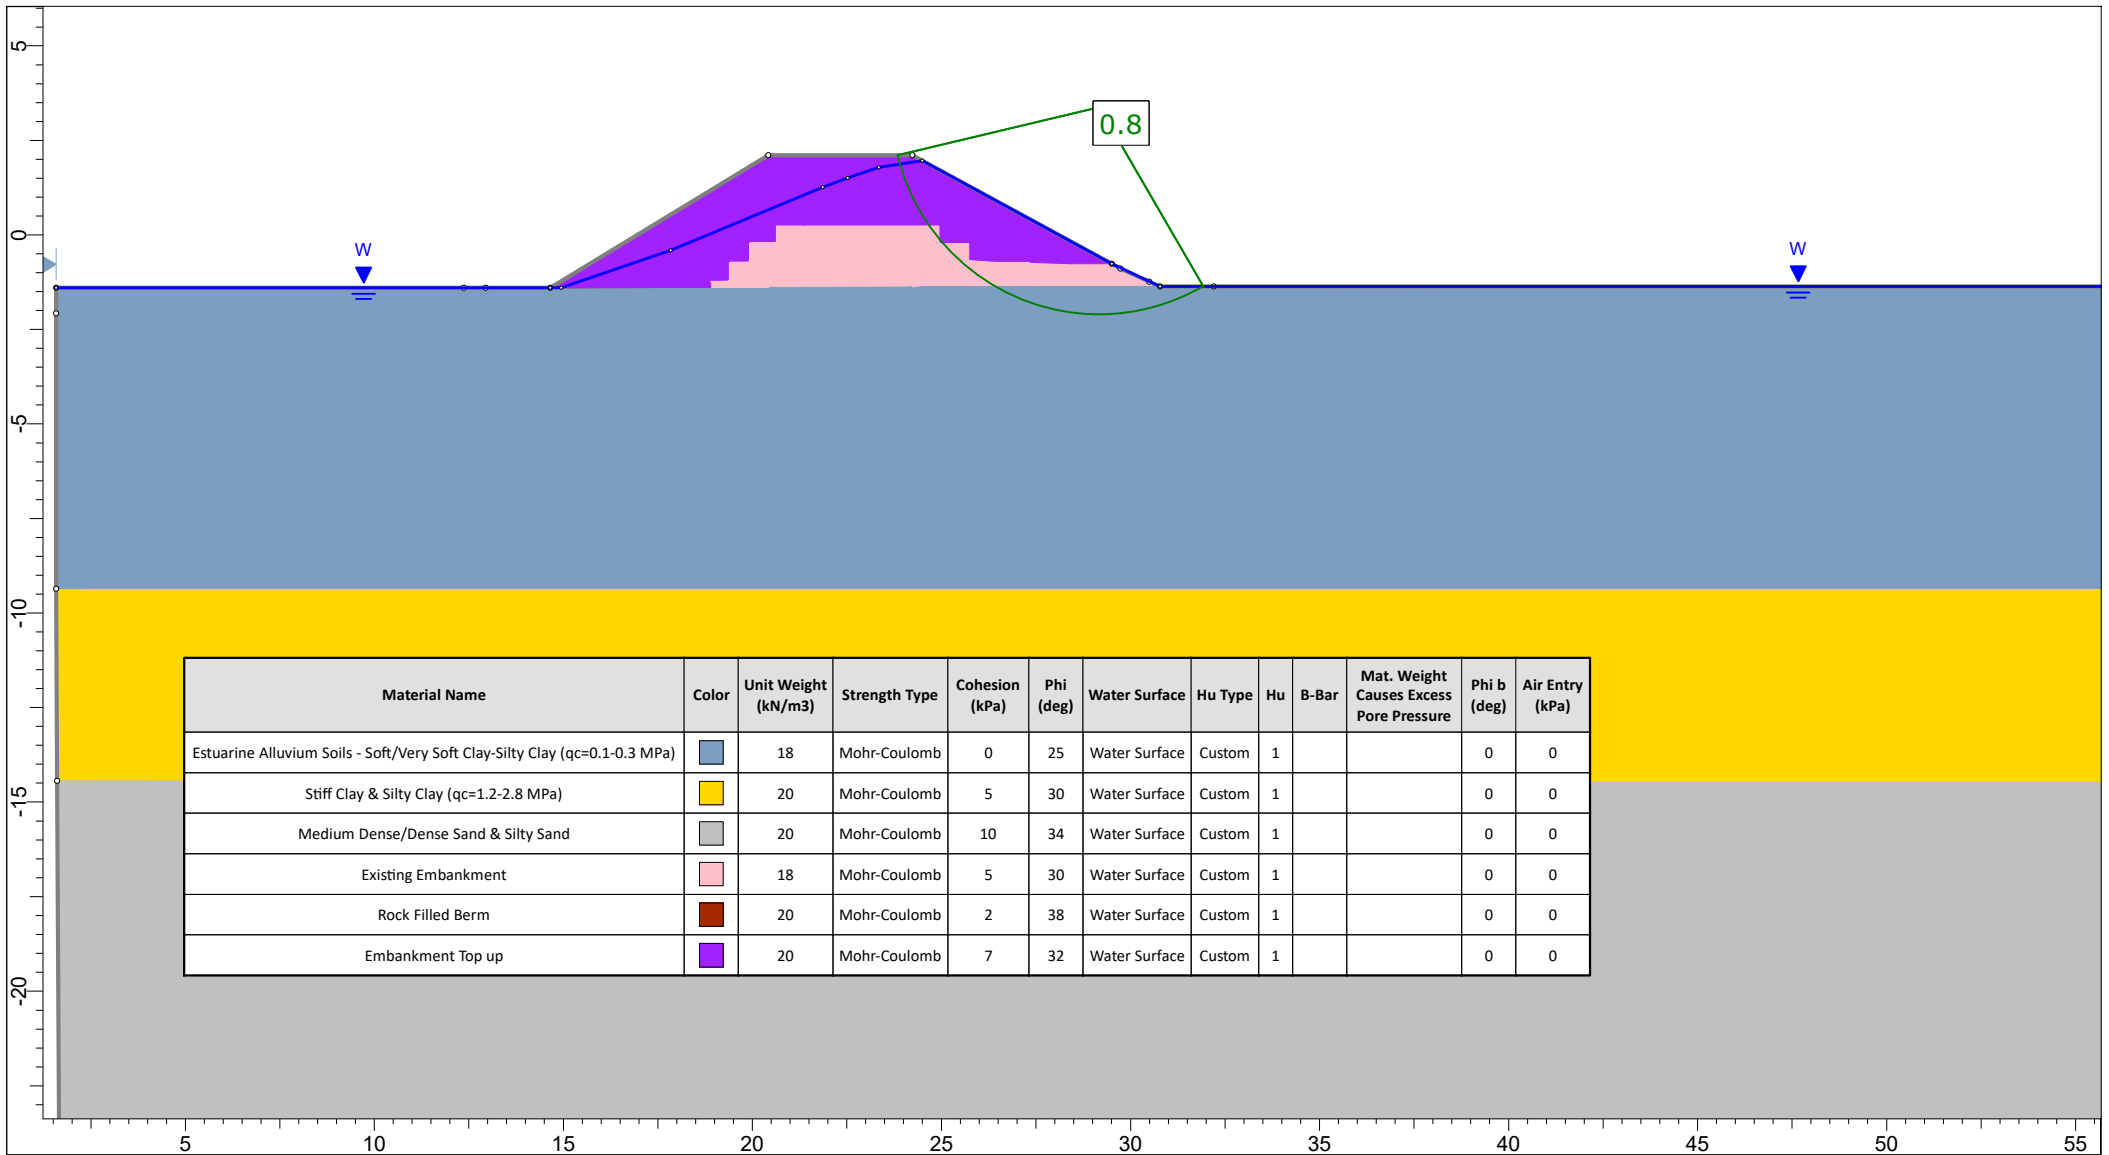
Material Name	Color	Unit Weight (kN/m ³)	Strength Type	Cohesion (kPa)	Phi (deg)	Water Surface	Hu Type	Hu	B-Bar	Mat. Weight Causes Excess Pore Pressure	Phi b (deg)	Air Entry (kPa)
Estuarine Alluvium Soils - Soft/Very Soft Clay-Silty Clay (qc=0.1-0.3 MPa)		18	Mohr-Coulomb	0	25	Water Surface	Custom	1			0	0
Stiff Clay & Silty Clay (qc=1.2-2.8 MPa)		20	Mohr-Coulomb	5	30	Water Surface	Custom	1			0	0
Medium Dense/Dense Sand & Silty Sand		20	Mohr-Coulomb	10	34	Water Surface	Custom	1			0	0
Existing Embankment		18	Mohr-Coulomb	5	30	Water Surface	Custom	1			0	0
Rock Filled Berm		20	Mohr-Coulomb	2	38	Water Surface	Custom	1			0	0
Embankment Top up		20	Mohr-Coulomb	7	32	Water Surface	Custom	1			0	0

Project			Bowergate Farm																			
	Analysis Description						Static conditions - Long term - Existing Stop Bank upgrade without ground improvement (GW=3.0m, Scenario 2)																
	Drawn By			SR			Scale			1:200			Company			WSP - Opus International Consultants							
	Date						02/02/2018, 3:59:23 PM						File Name						Static Conditions-Drained- with GI (GW=3.0; Scenario 2).slim

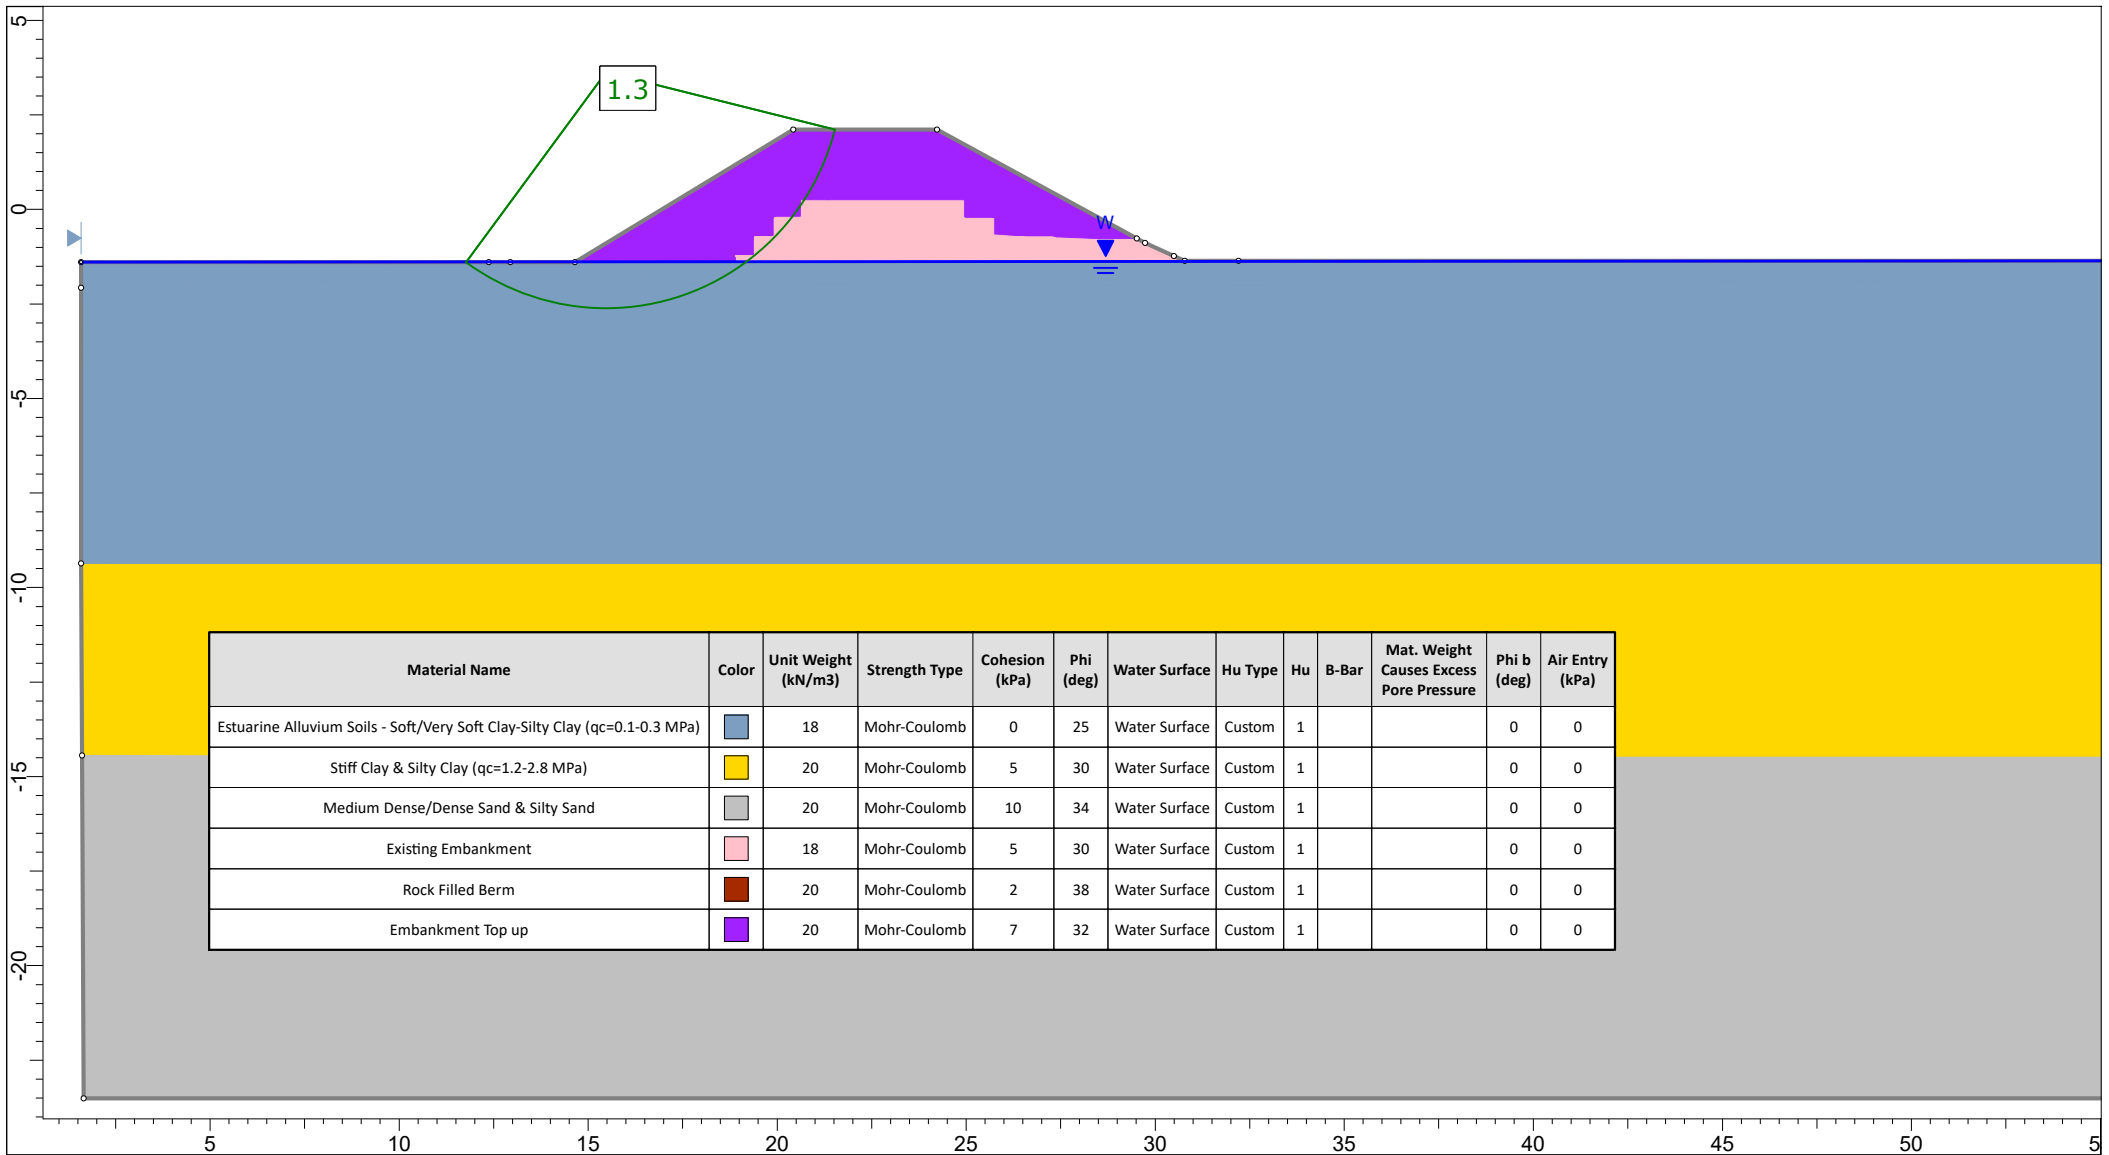
Material Name	Color	Unit Weight (kN/m3)	Strength Type	Cohesion (kPa)	Phi (deg)	Water Surface	Hu Type	Hu	B-Bar	Mat. Weight Causes Excess Pore Pressure	Phi b (deg)	Air Entry (kPa)
Estuarine Alluvium Soils - Soft/Very Soft Clay-Silty Clay (qc=0.1-0.3 MPa)	Blue	18	Mohr-Coulomb	0	25	Water Surface	Custom	1			0	0
Stiff Clay & Silty Clay (qc=1.2-2.8 MPa)	Yellow	20	Mohr-Coulomb	5	30	Water Surface	Custom	1			0	0
Medium Dense/Dense Sand & Silty Sand	Grey	20	Mohr-Coulomb	10	34	Water Surface	Custom	1			0	0
Existing Embankment	Pink	18	Mohr-Coulomb	5	30	Water Surface	Custom	1			0	0
Rock Filled Berm	Red	20	Mohr-Coulomb	2	38	Water Surface	Custom	1			0	0
Embankment Top up	Purple	20	Mohr-Coulomb	7	32	Water Surface	Custom	1			0	0

Project			Bowergate Farm																			
	Analysis Description						Static conditions - Long term - Existing Stop Bank upgrade without ground improvement (GW=0m, Scenario 1)																
	Drawn By			SR			Scale			1:200			Company			WSP - Opus International Consultants							
	Date						02/02/2018, 3:59:23 PM						File Name						Static Conditions-Drained- with GI (GW=0; Scenario 1).slim

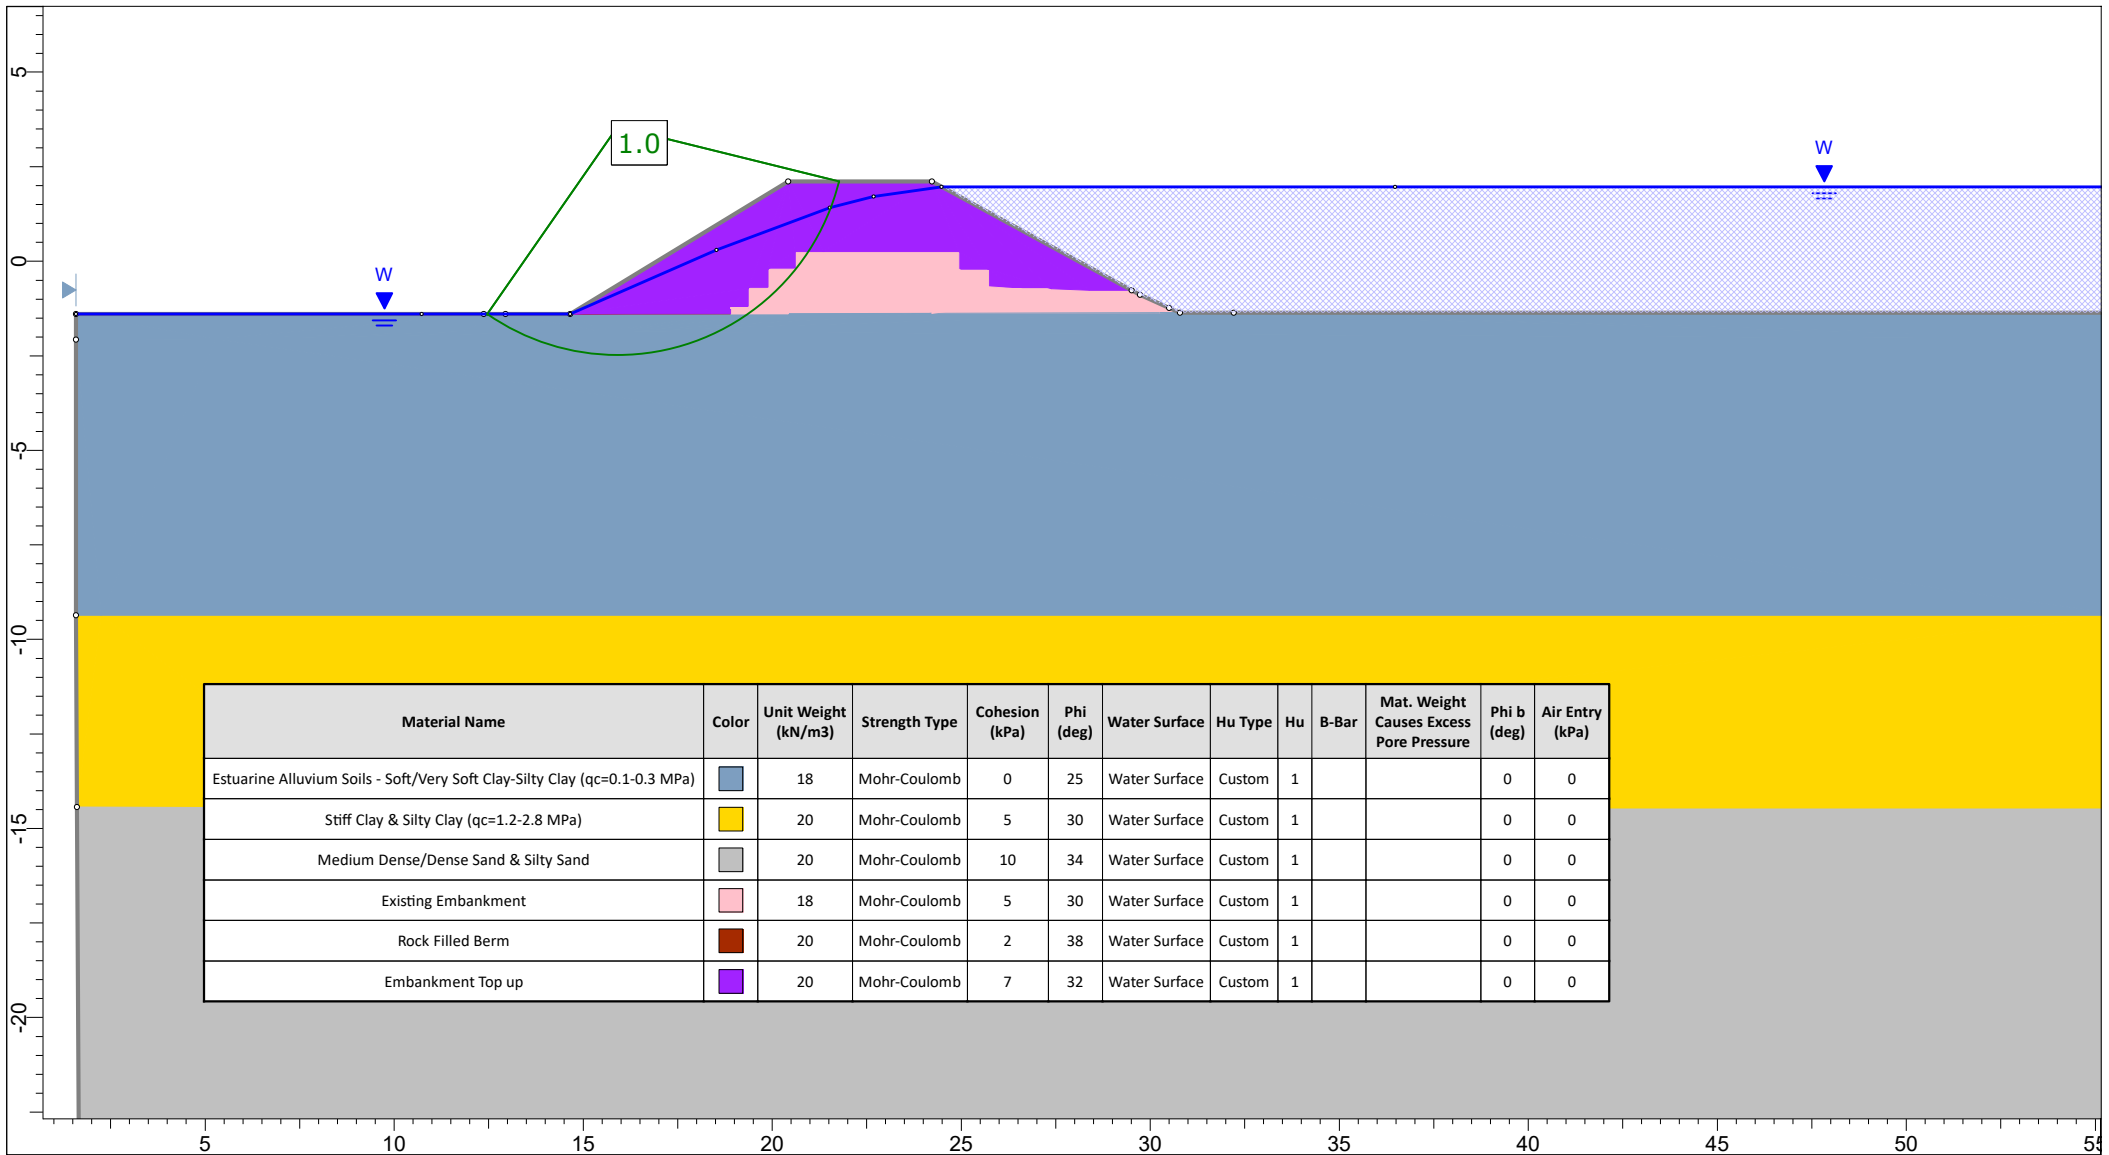
Material Name	Color	Unit Weight (kN/m ³)	Strength Type	Cohesion (kPa)	Phi (deg)	Water Surface	Hu Type	Hu	B-Bar	Mat. Weight Causes Excess Pore Pressure	Phi b (deg)	Air Entry (kPa)
Estuarine Alluvium Soils - Soft/Very Soft Clay-Silty Clay (qc=0.1-0.3 MPa)	Blue	18	Mohr-Coulomb	0	25	Water Surface	Custom	1			0	0
Stiff Clay & Silty Clay (qc=1.2-2.8 MPa)	Yellow	20	Mohr-Coulomb	5	30	Water Surface	Custom	1			0	0
Medium Dense/Dense Sand & Silty Sand	Grey	20	Mohr-Coulomb	10	34	Water Surface	Custom	1			0	0
Existing Embankment	Pink	18	Mohr-Coulomb	5	30	Water Surface	Custom	1			0	0
Rock Filled Berm	Red	20	Mohr-Coulomb	2	38	Water Surface	Custom	1			0	0
Embankment Top up	Purple	20	Mohr-Coulomb	7	32	Water Surface	Custom	1			0	0

Project			Bowergate Farm																			
	Analysis Description						Static conditions - Long term - Existing Stop Bank upgrade without ground improvement (GW=3.0m, Scenario 1)																
	Drawn By			SR			Scale			1:200			Company			WSP - Opus International Consultants							
	Date						02/02/2018, 3:59:23 PM						File Name						Static Conditions-Drained- with GI (GW=3.0; Scenario 1).slim
